Building Information

Address:	119 West Madison Street	PIN:	21-11-402-023	Plan:	Rectangular	Stories:	4
Original Owner:				Roof Type:	Hip		
Building Names:	LaSalle County Courthouse			Foundation:			
Important Dates:	1881, 1884			Walls:	STONE		
Architect / Builder:	Minard L. Beers, Weiss & Wolf (Carpenters), Thomas & Hugh Colwell (Contractors)			Sheathing:			
Architectural Style:	Late Victorian: Italianate			Windows:	Double-Hung		
Historic Function:	GOVERNMENT: courthouse			Doors:	METAL, GLASS		
Current Function:	GOVERNMENT: courthouse			Trim:	STONE		
References:				Roofing:			
				Flashing:			
				Chimney:	BRICK

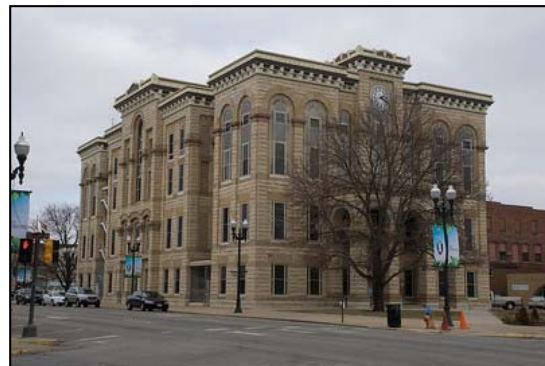
Photo ID: 121

The four-story stone courthouse presents a series of projecting rectangular bays which hold varying numbers of tall, two-story windows with roman arches. The primary façade, facing south towards the Illinois River, presents a central projecting bay with a single window, and a pair of single windows flanks this bay. The remainder of the façade is taken up by a wide bay on each side of the building, each presenting two arched windows. The arches are repeated in the two-story portico framing the main entrance. Four heavy stone piers with composite capitals support three arches, which in turn support a cornice of stone corbels and a low stone balustrade.

The ground floor of the building is slightly below grade, resulting in rather short windows near the ground level. These have heavy stone lintels, darker than the rusticated stone used for the walls.

The second floor windows, although taller, are treated the same way, with heavy lintels and narrow sills. However, the area between the windows is treated like a pilaster, which extends upward to the arched tops of the windows which themselves extend through the third and fourth floors. These pilasters end at stylized capitals that mimic the shape of those on the portico, and visually support the arched window surrounds. Above these arches is a complex bracketed cornice.

The other facades of the building repeat these design features, with five protruding bays on the east and west façades, and three on the north façade.

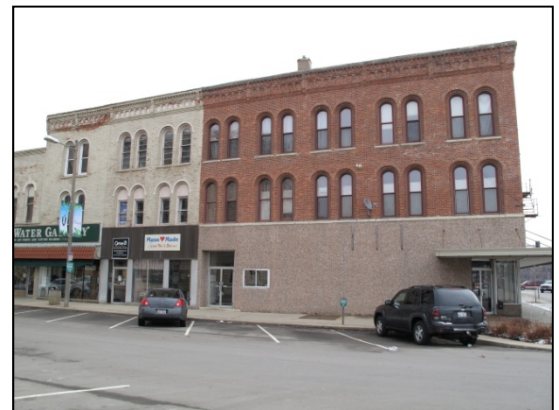
Photo ID: 043

Three-story red brick commercial structure with office or dwelling space above first-floor retail. The storefront has been replaced by a metal and glass contemporary unit. The second and third floors each present two window bays, with a pair of windows with Roman arches in each bay. The four sets of windows each have narrow stone sills. Each window is set back in the wall; a hood is suggested by a single course of rowlocks framing each arch. The third-floor windows appear to be original; those on the second floor appear to have been replaced in the early 20th century with shorter wooden windows. An ornate cornice of brick including a sawtooth course machicolations and the suggestion of brackets decorates the parapet. The cornice and windows tie this building visually to the two buildings on either side. The building has been painted, which may have aggravated the spalling on the second and third floors.

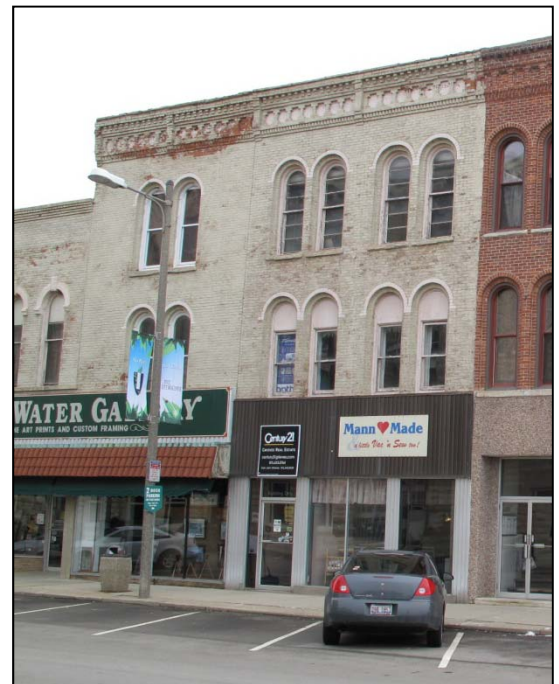
Photo ID: 610 on left - 043

Three-story red brick commercial structure with office or dwelling space above first-floor retail. The storefront has been replaced by a metal and glass contemporary unit having a built-in overhang of clay tile which stretches across both 610 and neighboring 608. The second and third floors each present one window bay, with a pair of windows with Roman arches. The two sets of windows each have narrow stone sills. Each window is set back in the wall; a hood is suggested by a single course of rowlocks framing each arch. The second-floor windows appear to be original; those on the third floor appear to have been replaced with contemporary wood or vinyl windows. These windows' rectangular profiles are obvious in the arched window surrounds. An ornate cornice of brick including a sawtooth course, machicolations and the suggestion of brackets decorates the parapet. The cornice and windows tie this building visually to the two buildings to the south. The building has been painted, which may have aggravated the spalling on the second and third floors.

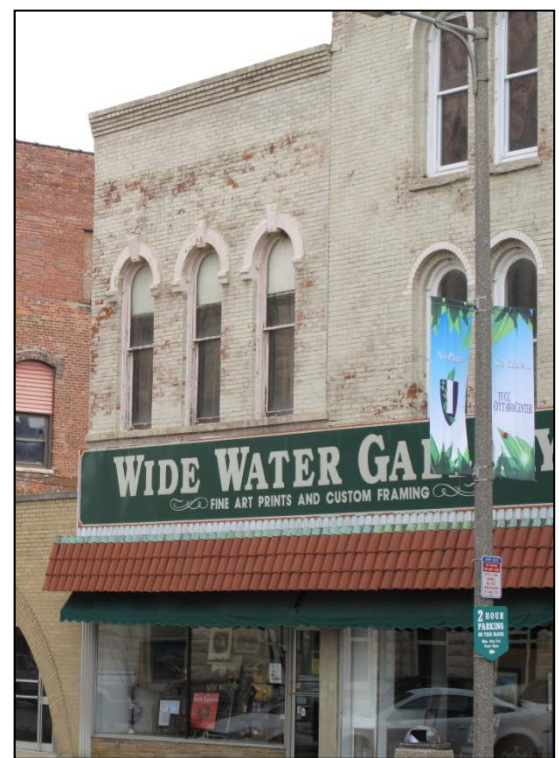
Photo ID: 044

Two-story red brick commercial structure with office or dwelling space above first-floor retail. The storefront has been replaced by a metal and glass contemporary unit having a built-in overhang of clay tile which stretches across both 608 and neighboring 610. The second floor presents three evenly spaced windows with Roman arches. Stone hoods with exaggerated keys mark each arch, and a single sill stretches across the façade beneath the window, which appear to be original. The cornice is formed by a corbel consisting of four courses of brick alternating headers and stretchers. The building has been painted, which may have aggravated the spalling on

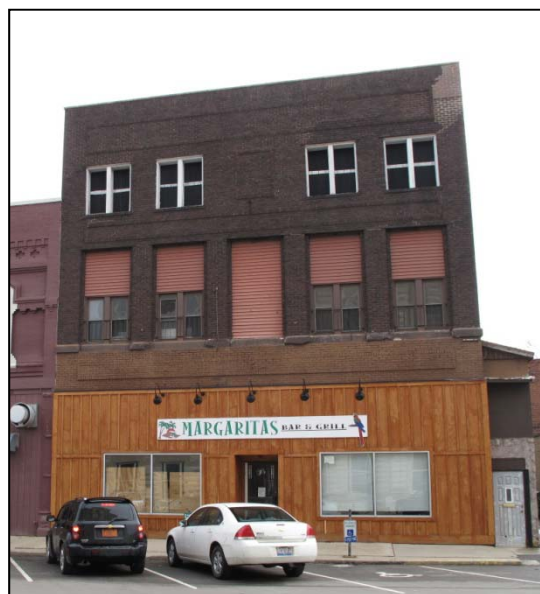
Photo ID: 050

Three-story brick commercial structure with office or dwelling space above first-floor retail. The storefront has been replaced by a wood and glass contemporary unit having a central entry flanked by pairs of plate-glass windows. The secondary façade shows red brick with window hoods of brick topping segmental-arch windows. The main façade on the second and third floors, however, has been replaced with dark brown brick. The area between the storefront and second floor windows is filled with brown brick with a raised central panel. A string course of stone serves as sills for the windows above. The second story presents five window penetrations. The central penetration is completely filled with wooden siding; the other four penetrations each present two small double-hung windows with the remainder of the penetration filled with wood siding. On the third floor, the central bay presents a raised panel of brick, and the other four each present a pair of double hung windows. The parapet is adorned by simple changes to the bond, such as the soldier's course near the top. Significant repair work has been done on the south corner of the parapet, using unmatched brick and inappropriately wide mortar. Façade replacement in early 20th century.

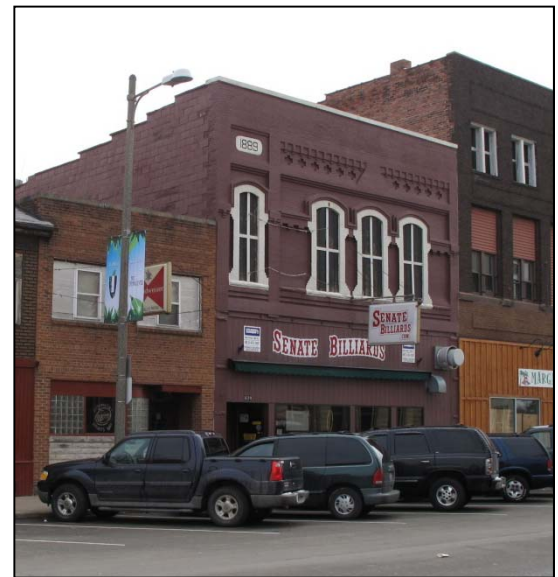
Photo ID: 047-1

Two-story red brick commercial structure with office or dwelling space above first-floor retail. The storefront has been replaced by a wood and glass contemporary unit. The cast iron beam supporting the second story masonry wall is still visible, along with nine rosettes. The second story façade is fairly complex. A single bay, one-window wide, is visually separated from the rest of the building. It is likely that this narrow bay originally housed an exterior door to the second floor. A group of three windows is centered in the remaining bay. These divisions of the façade are marked by decorative brick features. The bays are inset from the outermost plane of the wall, and decorative brickwork forms heavy frames around the segmental-arch windows, as well as hoods for those windows. In a playful reversal of conventional brickwork, the complex brick designs usually reserved for the cornice and parapet in buildings of this period is applied to a band directly above the larger window bay, leaving the cornice and parapet wall above completely flat. In the corresponding space above the single-window bay is a plaque with the building's construction date, 1889. Brown and white paint applied to the second floor façade draws attention to the framing around the windows. The first floor served originally as a laundry.

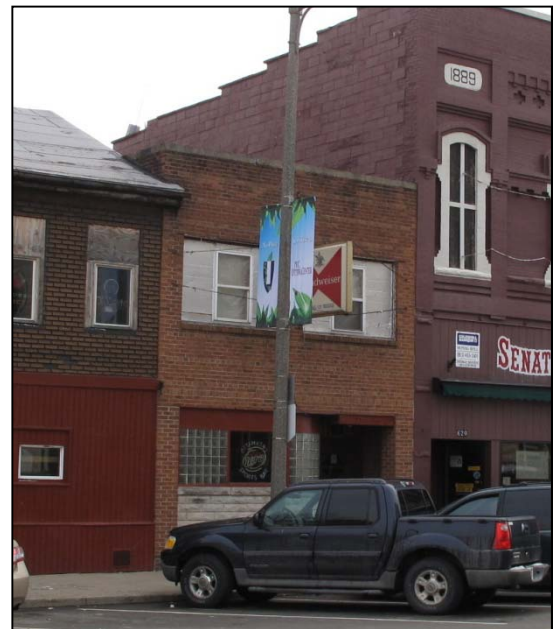
Photo ID: 047-1

Two-story orange brick commercial structure with office or dwelling space above first-floor retail. The storefront has been replaced by one of glass block and faux stone that curves inward to the entryway on the right. Variations in the brick's common bond pattern provide the primary decorative features of this building. A row of soldiers separated the first and second floors, and rowlocks serve as sills on the two evenly-spaced second-story window penetrations. These have been filled with a reflective-faced sheathing and present a single double-hung contemporary window in the center of each penetration. A simple course of cast stone serves as coping for the façade and storefront appears to have been replaced in the 1930s.

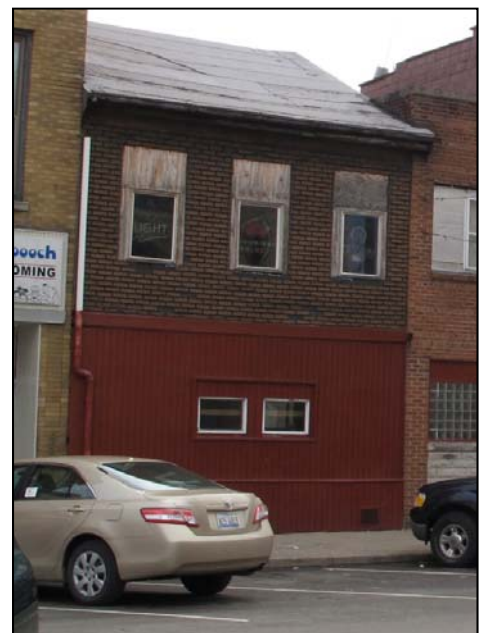
Photo ID: 047-1

A two-story structure, apparently of wooden frame construction, with a side gable roof angled towards the street. The entire first floor has been replaced by vertical wooden siding with two small windows. The second floor has what appears to be faux brick attached to the façade. Three window penetrations, which have been partially filled with plywood, each present a small rectangular inoperable window.

The structure's massing is identical to early buildings documented in a photo of LaSalle Street dating to 1860. The earliest Sanborn identifies the occupant as a barber.

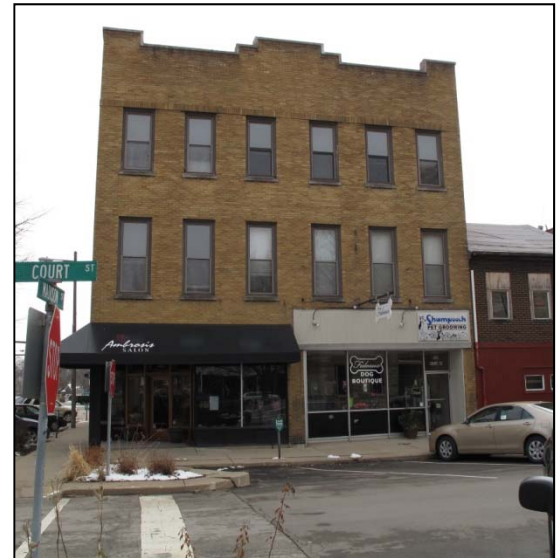
Photo ID: 138-1

Three-story yellow brick commercial structure with office or dwelling space above first-floor retail. The storefronts have been replaced by wooden, metal and glass entryways to multiple shops. The upper floors of the building remain practically unchanged since the building was constructed. The west façade, facing Court Street presents six windows at the second and third floors, with the third floor windows being slightly shorter than those on the second floor. The only decoration consists of a row of soldiers stretching across the façade above the third-floor windows, and a simple rectangular pediment suggested by the varying height of the parapet wall. The secondary façade, facing Madison street, presents an unadorned wall of brick with eight windows on the second and third floors. The central pediment is repeated on the parapet.

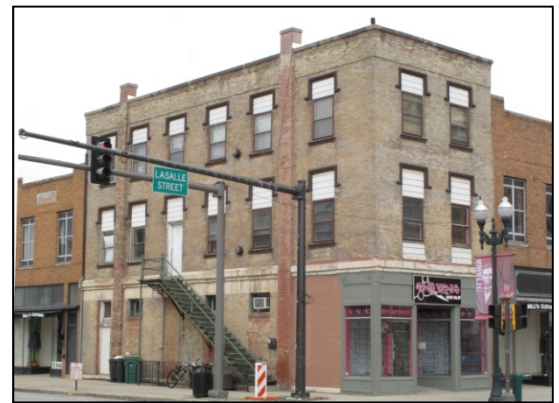
Photo ID: 071

Three-story brick building with what appears to be a period storefront. Window penetrations on second and third floors are partially filled with contemporary siding and present small contemporary double-hung windows. The brick has been painted, which likely contributes to spalling. On the Main Street façade, exterior stairs to the second floor and cellar and brick chimney flues protruding from the wall together make this building unique in downtown Ottawa.

Original brick storefront removed after bank moved in 1904. Despite the replacement windows, a case could be made for individual listing.

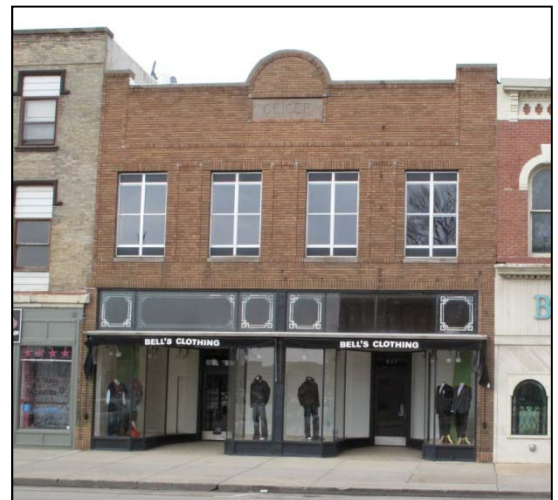
Photo ID: 072

A two-story brick structure wraps around 601 LaSalle Street, with storefronts on both LaSalle and Main Streets. The Geiger Building has been at this location since before the 1888 Sanborn Maps were published. As with other buildings in downtown Ottawa, the façades of this building have been completely reworked, in this case with orange brick. Both facades include a cast stone plaque with the name Geiger engraved upon it. Although the second floor windows have been replaced with contemporary replacements, the storefronts appear to date back to the time of the façade renovation, particularly the Main Street storefront.

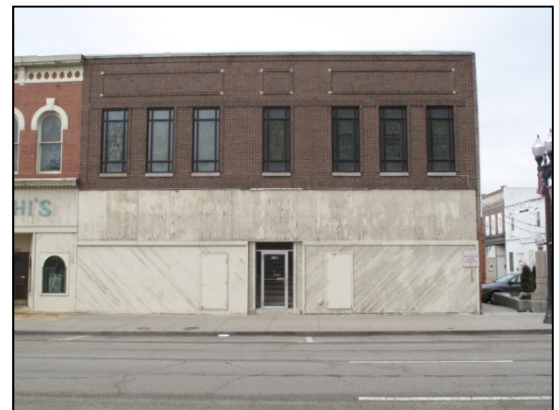
Photo ID: 225

Two-story, seven-bay brick structure with office or residential space on second floor. Storefront of contemporary wooden siding extends up to second floor. Second floor façade appears to have been replaced with brown brick.

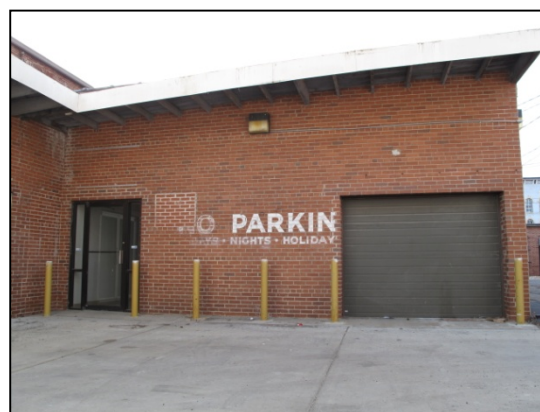
Photo ID: 073-1

Originally used as a warehouse, this utilitarian brick structure with flat roof opens onto the alley. A number of window and door penetrations have been filled with brick, CMUs and contemporary windows. A contemporary addition in brick adjoins the historic structure.

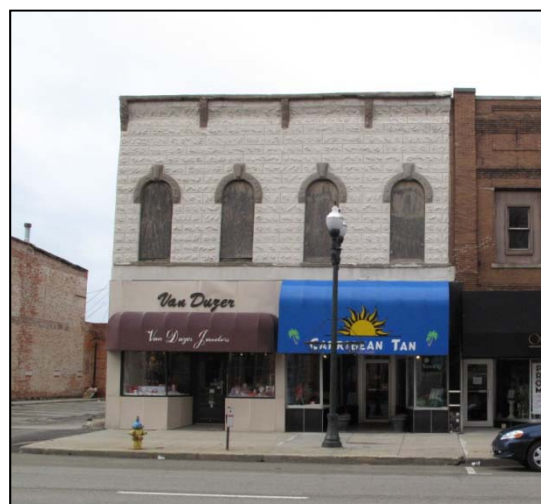
Photo ID: 074

Two-story, four-bay brick structure with office or residential space on second floor and two storefronts on the first floor. Storefronts are of contemporary metal and glass and include awnings. Second floor window penetrations appear to be original, but the brick façade has been covered with a material intended to mimic rusticated stone. This material and finish are applied to the window hoods and what was once a decorative cornice at the top of the parapet wall. Window openings have been boarded up.

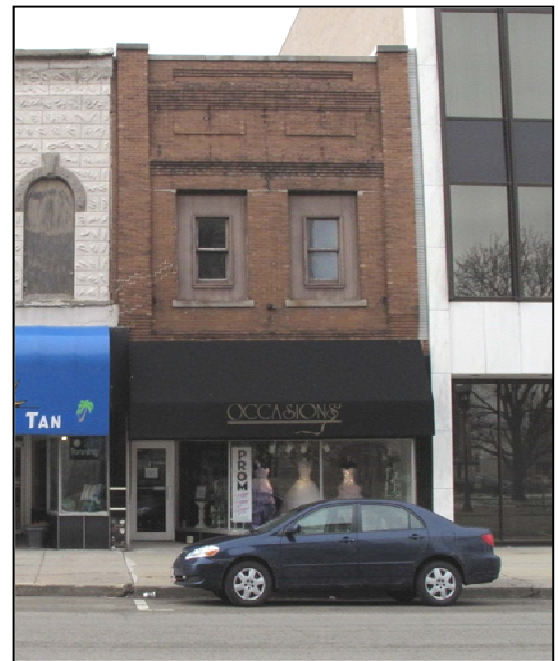
Photo ID: 074

Two-story, two-bay brick structure with office or residential space on second floor. Storefront of contemporary metal and glass with an awning account for the first floor façade. Second floor façade of light brown brick with two relatively short windows with narrow stone sills. Window penetrations are partially filled with wooden siding and small contemporary replacement windows. Simple variations in bond patterns decorate the area above the windows to the parapet. Bond patterns are consistent with early 20th-century commercial structures.

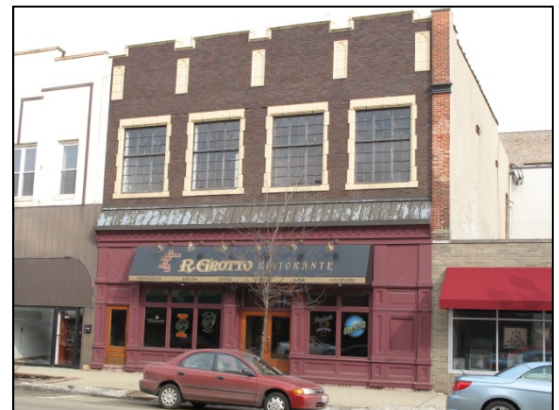
Photo ID: 079

Two-story brown brick commercial structure with office or dwelling space above first-floor retail. The storefront has been replaced by a wood and glass contemporary unit. Though the storefront has features that suggest Victorian construction practices, it is not in keeping with the decorative features on the second floor, which suggest elements of the Gothic Revival Style. On the second floor, four large window penetrations, each holding six metal casement windows arranged in stacked pairs, are edged in buff-colored terra cotta in a pattern reminiscent of stone window surrounds in Gothic buildings. The parapet is decorated with what appear to be five statue niches, also in buff terra cotta. Though too shallow to actually hold a statue, each of these decorative features present a arch ending in a trefoil. Each of these five features are centered beneath a shallow embrasure, which produces the effect of a crenellated parapet, finished with buff-colored terra-cotta coping. This façade is likely the addition of a “stone” façade first noted on the Sanborn Map of 1913.

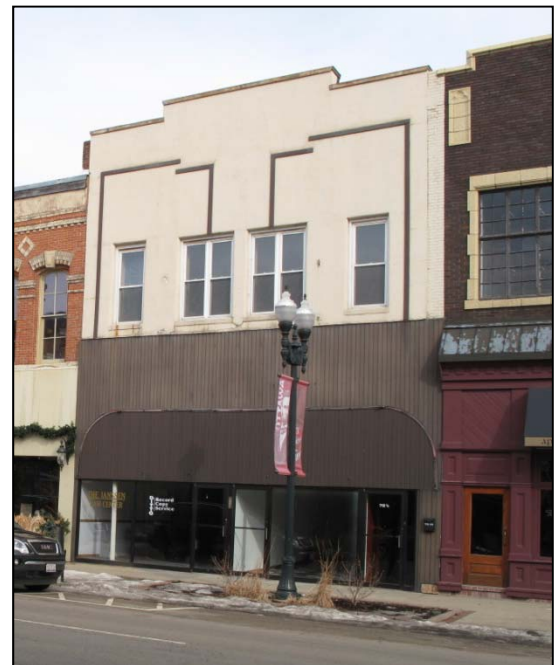
Photo ID: 080

Two-story masonry commercial structure with office or dwelling space above first-floor retail. The storefront has been replaced by a contemporary storefront of vertical wood siding and glass. The second floor façade has been covered in stucco. Wooden trim painted to match the storefront provides relief from the otherwise featureless surface. Six contemporary replacement windows are arranged in four groups, with two pairs of windows centered with a single window on either side of the pair. The parapet is slightly higher in the center, suggesting a rectangular parapet as is common on other buildings in the area dating from the 1920s.

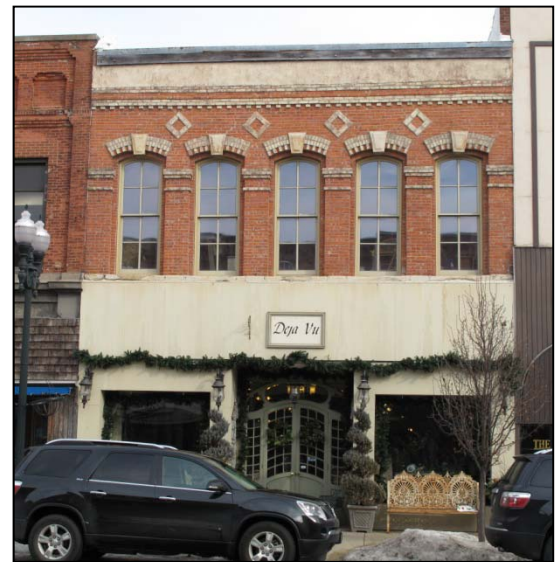
Photo ID: 081

Two-story red brick commercial structure with office or dwelling space above first-floor retail. The storefront has been replaced by a wood and glass contemporary unit. The second floor façade is essentially unchanged from the date of construction. Five windows with segmental arches are evenly spaced across the façade, with the four-over-four windows either being original or well-designed replacements. At a point about two-thirds up from the bottom of the windows are a series of corbelled courses in contrasting buff brick: a single course, topped by three courses of red brick, followed by three courses of buff brick. The same buff brick is used to suggest hoods over the windows, with a large keystone in the center of each. Above the windows, the contrasting brick is again used to outline four diamond-shaped projections. A few courses above, the buff brick reappears as an element in the cornice. Double courses of buff brick alternate with the red, topped by a stucco finish on the last few courses at the top of the parapet. Wooden planks and galvanized metal coping top the parapet.

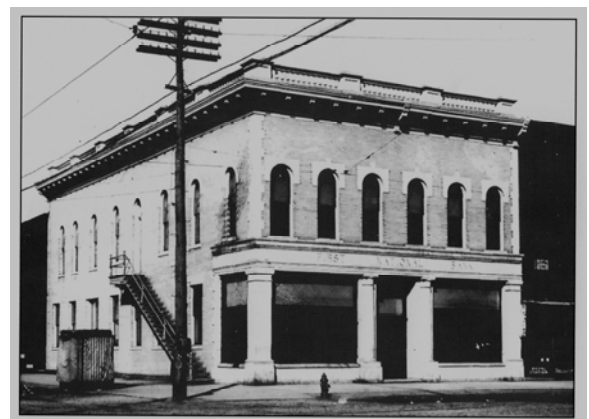
Photo ID: Ottawa010

Originally three red brick two-story commercial structures with residential or office space above, the building's most recent renovation ties all three structures in by extending a storefront across all three buildings. Other work included painting the brick and stone window hoods, painting the building, and replacing the second-story windows. Although some of this work detracts from the building's integrity, the building's massing, proportions and basic design have been maintained and most changes are sympathetic to the building's original design. The northern-most of the three buildings maintains its original ornate brick cornice.

Expanded in 1909 to include adjacent storefront.

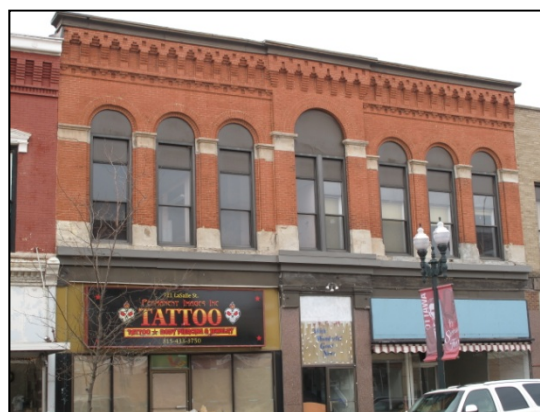
Photo ID: Left - 084

Changes to the first floor storefront are sympathetic to the building's original design.

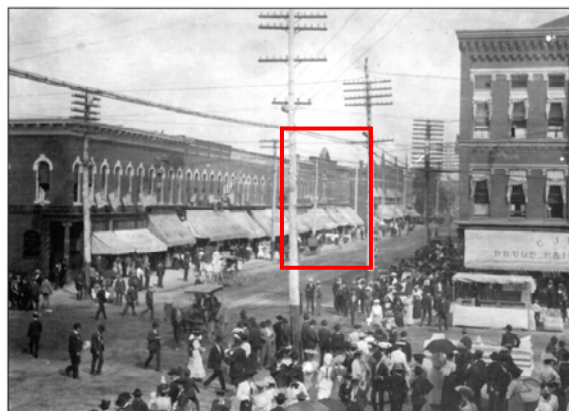
Photo ID: Ottawa005

Red brick two-story commercial structure with residential or office space above, combined with its neighbor, no. 725. An ornate cornice of brick, series of Roman arched windows with stone accents are all in excellent condition.

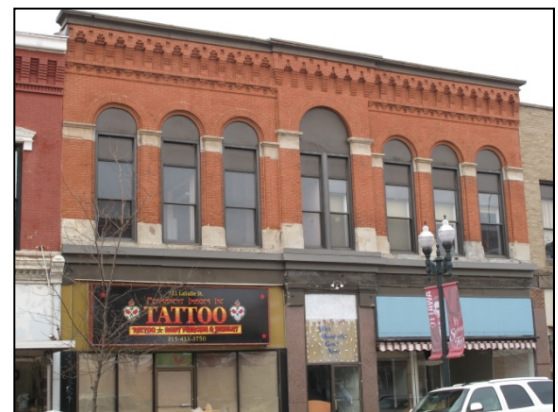
Photo ID: Right - 084

Changes to the first floor storefront are sympathetic to the building's original design.

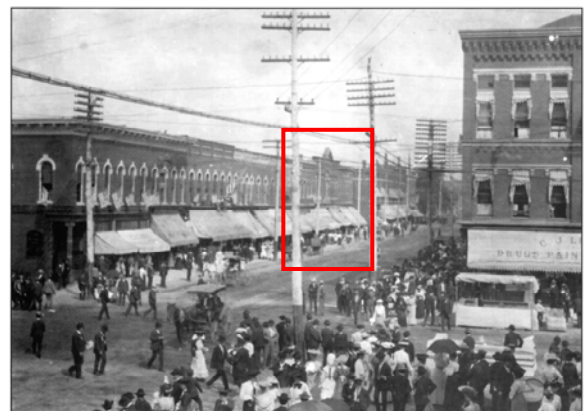
Photo ID: Ottawa005

Red brick two-story commercial structure with residential or office space above, combined with its neighbor, no. 721. An ornate cornice of brick, series of Roman arched windows with stone accents are all in excellent condition.

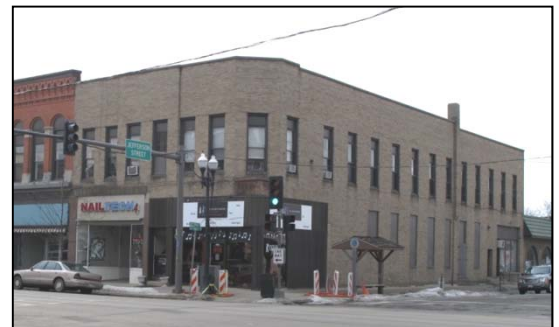
Photo ID: 112

Two-story brick commercial structure with residential or office space above. Renovations dating to the late 20th century appear to have replaced the entire brick façade with plain brown brick. The original window penetrations seem to have been maintained, and the building's massing and form allow it to serve as a contributing structure.

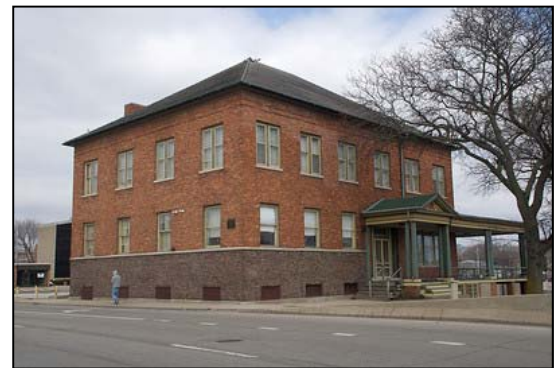
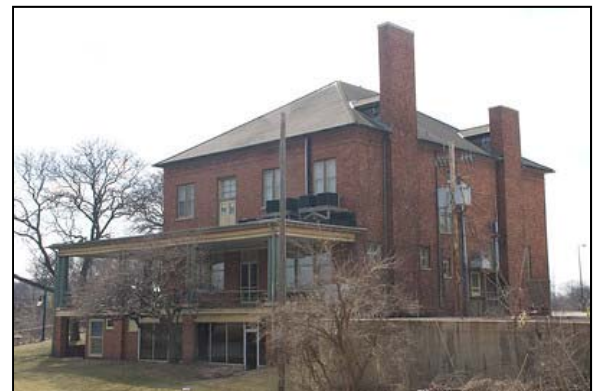
Photo ID: 014-1

A square, two-story brick building with a basement level at grade facing the river. The main façade faces the river, presenting six window bays. A classically-inspired porch with paired Doric columns supporting a porch roof with pediment fills the fourth bay from the left. The bays to the left of the entrance each present a single double-hung window. To the right of the entrance, the porch and roof extend to the end of the building and wrap around the east façade, where the grade is considerably lower.

Brick piers support the first floor porch; pairs of Doric columns support the second floor porch, which currently has no rail. The north façade is utilitarian, presenting multiple chimneys, service entrances and small windows. On the west façade, four bays wide, each bay presents a single double-hung window on the first floor and a pair of similar windows in each penetration on the second floor. This pattern of second floor windows is repeated on the south façade. All windows, doors and trim appear to be original.

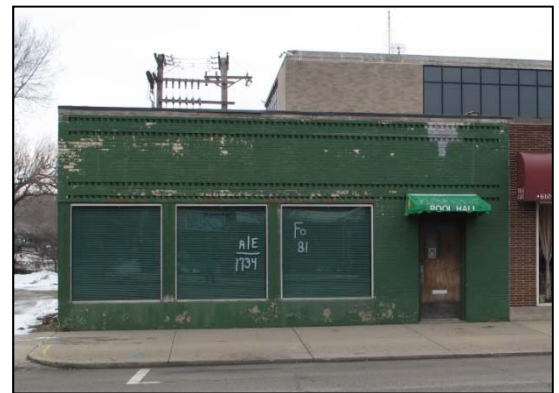
Photo ID: 019

Single-story storefront of brick with a narrow entrance and three large windows. The arrangement of four distinct windows in a brick façade suggests the building was not intended for retail. Sawtooth courses begin a few bricks in from each end of the façade. Two sawtooth courses separated by three courses of stretchers extend above the windows and just below the edge of the parapet. The façade has been painted a number of times, and the door has been replaced.

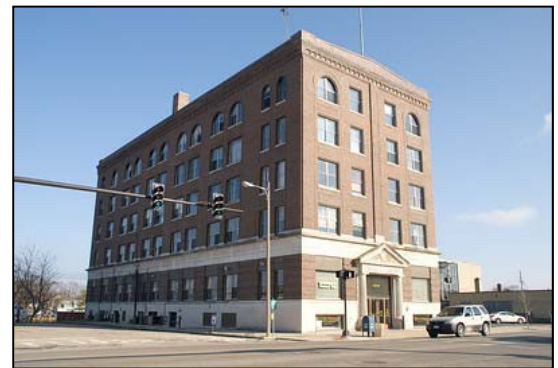
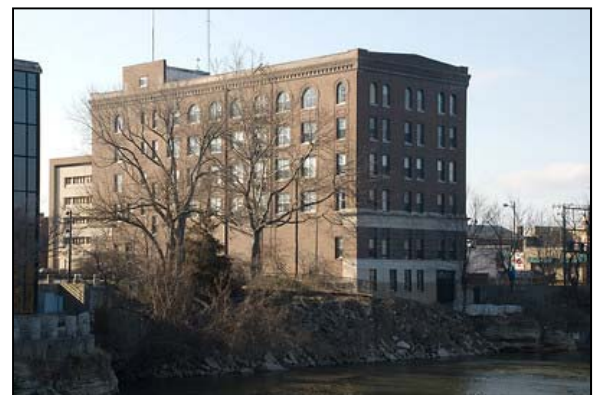
Photo ID: 023-1

Five-story Classical Revival office building in dark brown brick retains all original masonry features. A modest entryway with an engaged Doric column on either side supporting a pediment. The entablature presents the name of the building in raised letters. In keeping with the Classical design, the building is divided into three parts. The first floor, including the entry, has a heavy stone foundation and an entablature of stone extending behind the pediment across the façade. The second segment of the façade consists of the four upper floors, each of which presents four window penetrations. The two central penetrations each hold one double-hung window; the others each present two windows. These paired windows are separated by spandrel panels of brick including soldier and rowlock courses. The double windows on the top floor are framed by a brick arch. The third and final portion of the façade includes a decorative brick cornice beneath a shallow brick pediment, which, like the rest of the parapet, is finished with plain coping in stone.

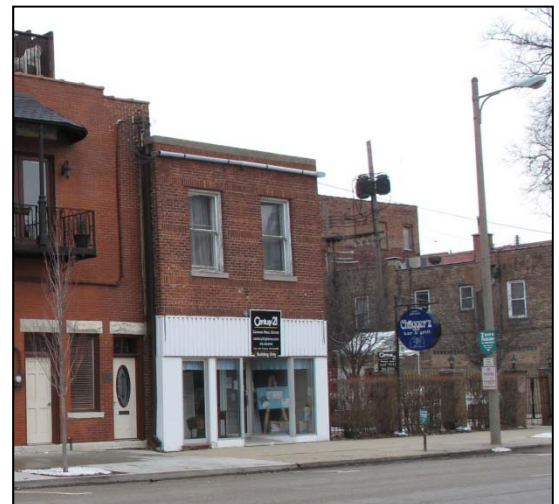
Photo ID: 017

Simple two-bay two-story red brick commercial structure with office or dwelling space above first-floor retail. Variations in the brick's common bond pattern provide the primary decorative features of this building. Five rows of soldiers are evenly spaced across the second-floor façade: one at the division between first and second stories; one each at the bottoms, middle and tops of the second story windows; and one at the top of the parapet wall. The second floor windows appear to be original, though the storefront has been replaced with metal and glass with stucco and paint covering any masonry.

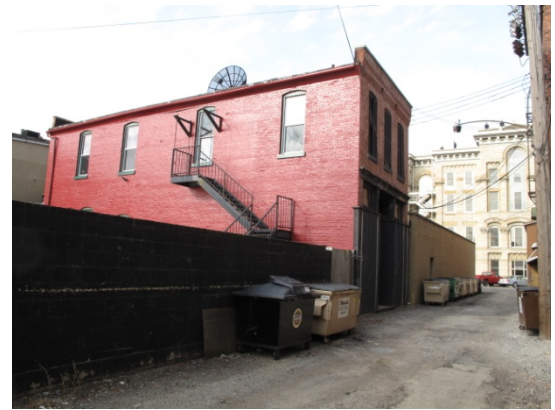
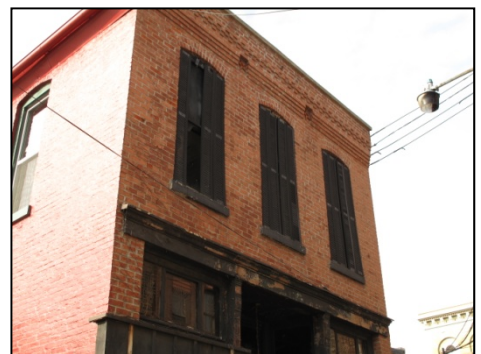
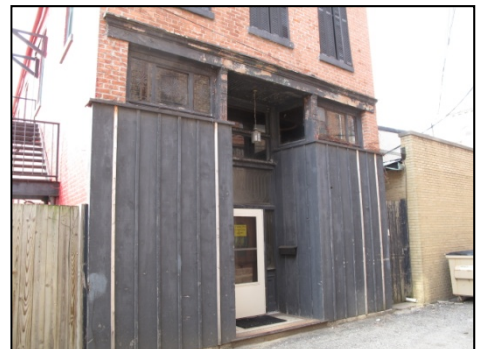
Photo ID: 021-1

This two-story brick building faces the alley and has remarkable integrity, from its leaded glass windows to the shutters on the second floor windows. A cast iron storefront appears to be intact behind wooden siding. A simple corbelled cornice of brick with alternating machicolations decorates the parapet.

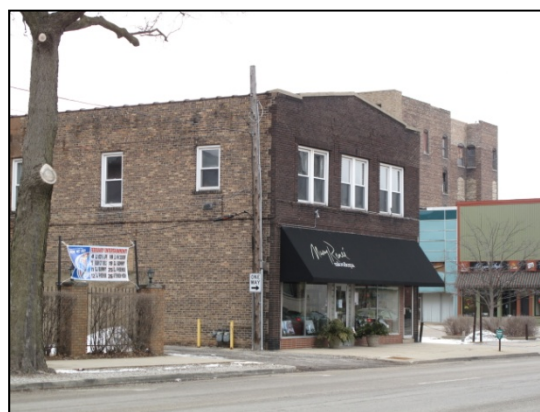
Photo ID: 022

Two-story dark-brown brick commercial structure with office or dwelling space above first-floor retail. The only ornamentation is the suggestion in brick of lintels, sills and hoods around the second-floor windows and the suggestion of a shallow pediment at the top of the parapet wall. The storefront has been replaced with metal and glass and red roman brick. Second floor windows have also been replaced.

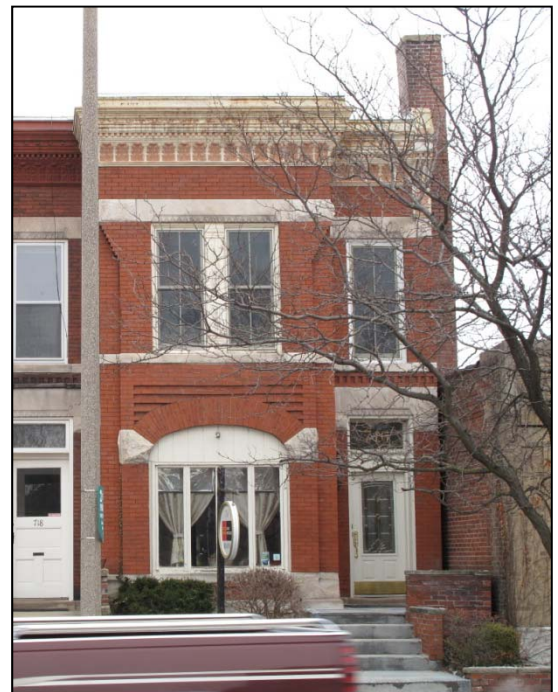
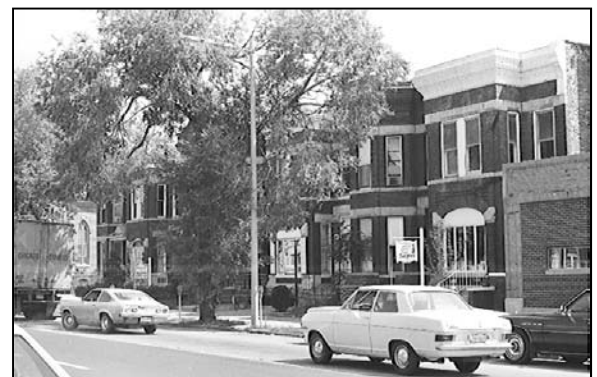
Photo ID: 026

One in a series of late Victorian rowhouses of brick with limestone features and a decorative cornice of painted metal. The prominent first floor feature of this unit is the large arched window opening to the left of the entryway. Windows and doors appear to be contemporary replacements.

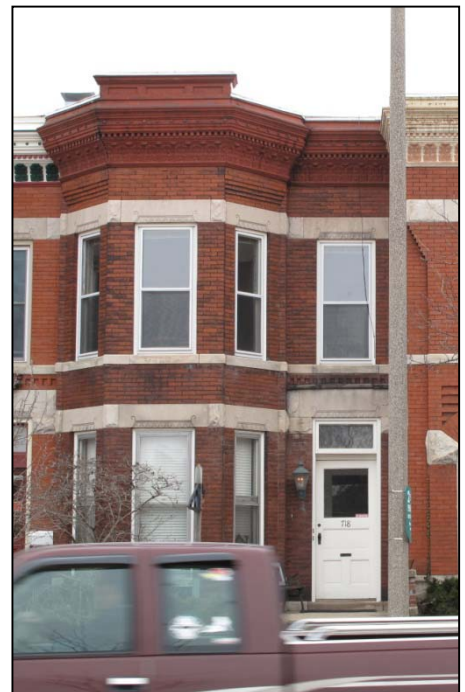
Photo ID: 026

One in a series of late Victorian rowhouses of brick with limestone features and a decorative cornice of brick. The prominent first floor feature of this unit is the protruding bay with three windows to the left of the entryway. Heavy courses of carved stone mark the tops of the windows and entry. Windows and doors appear to be contemporary replacements.

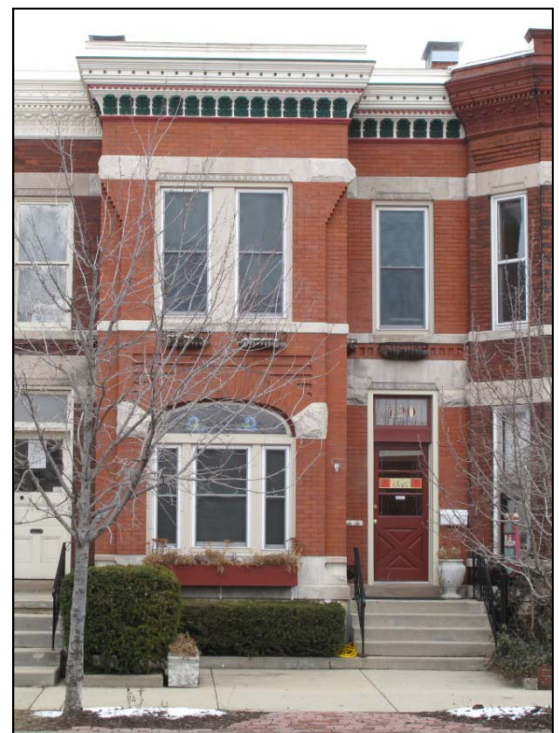
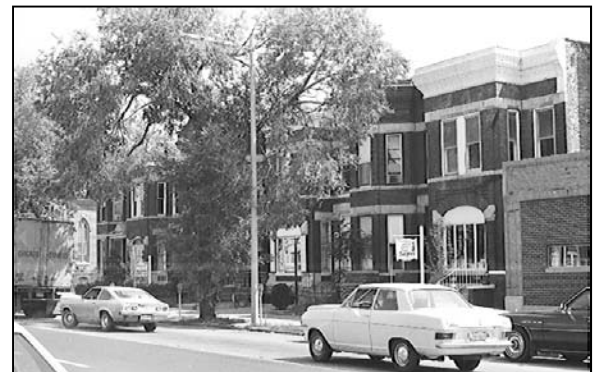
Photo ID: 028

One in a series of late Victorian rowhouses of brick with limestone features and a decorative cornice of painted metal. The prominent first floor feature of this unit is the large arched window opening to the left of the entryway. Windows and doors appear to be contemporary replacements, though a stained glass fan light may be original to the building.

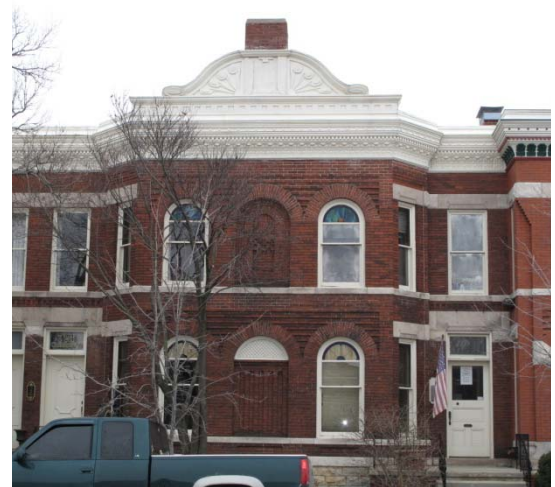
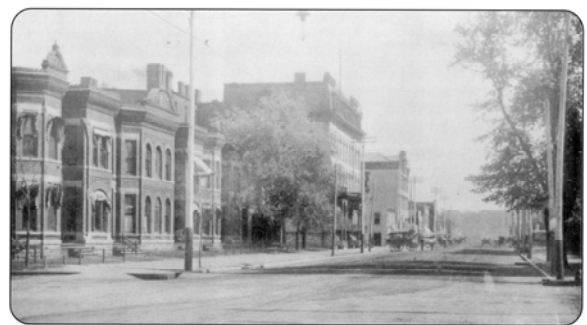
Photo ID: 722 on right - 030

One in a series of late Victorian rowhouses of brick with limestone features and a decorative cornice of painted metal. The prominent first floor feature of this unit is a large protruding bay presenting three window bays on the front and one window on each angled side. Three arches fill the front on each floor, the center arch filled with brick and the others presenting windows with fan lights of stained glass. This bay is apparently shared by the neighboring unit. Heavy stone lintels and narrow stone sills provide interest on the second floor. Mark the tops of the windows and entry. Windows and doors appear to be original.

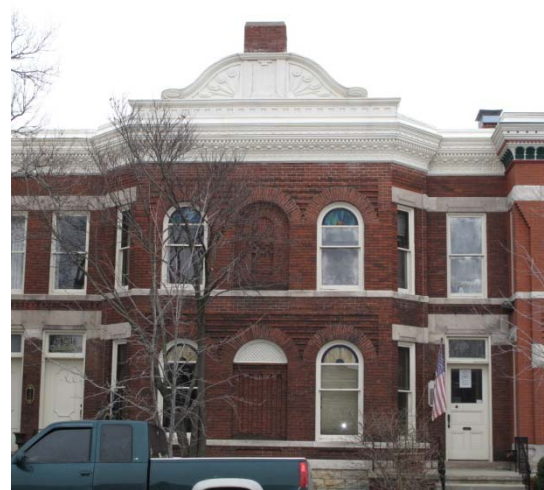
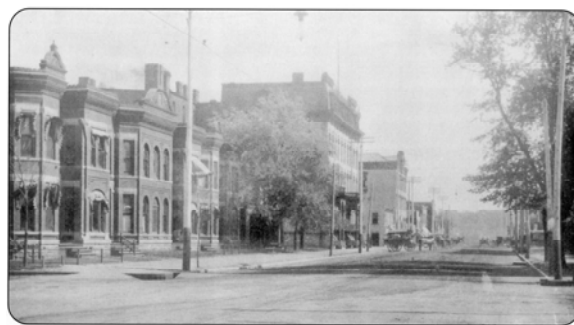
Photo ID: 724 on left - 030

One in a series of late Victorian rowhouses of brick with limestone features and a decorative cornice of painted metal. The prominent first floor feature of this unit is a large protruding bay presenting three window bays on the front and one window on each angled side. Three arches fill the front on each floor, the center arch filled with brick and the others presenting windows with fan lights of stained glass. This bay is apparently shared by the neighboring unit. Heavy stone lintels and narrow stone sills provide interest on the second floor. Mark the tops of the windows and entry. Windows appear to be original. The front door appears to be a contemporary replacement.

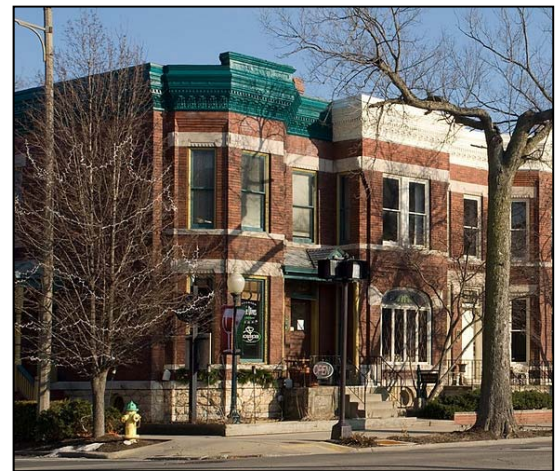
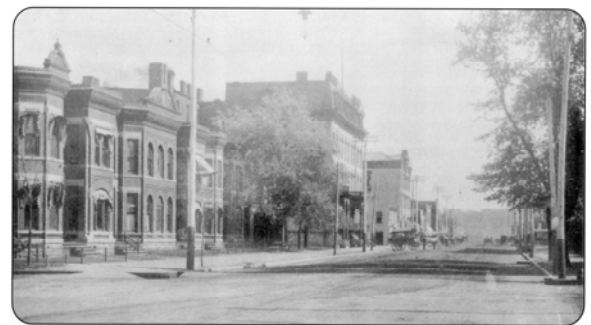
Photo ID: 726 on right - 031

One in a series of late Victorian rowhouses of brick with limestone features and a decorative cornice of painted metal. The prominent first floor feature of this unit is the large arched window opening to the left of the entryway. Windows appear to be original, as does a stained glass fan light above the first floor windows. The front door appears to be a contemporary replacement.

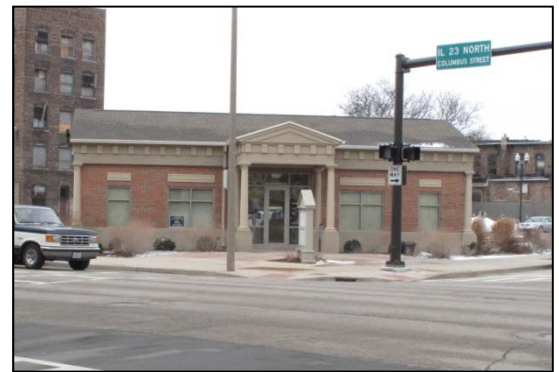
Photo ID: 029

Class:	Building	Condition:	Excellent	Integrity:	High
No	1. Heritage value	Individual Eligibility			
No	2. Events (A)	Scope:	Local		
No	3. Persons (B)	NHL:	No	Individual	No
			NR:		
No	4. Architect (C)	District Eligibility			
No	5. Design Elements (C)	District Name:	Ottawa Commercial Historic District		
No	6. Architectural Style (C)	Contributing:	No		
No	7. Archaeology (D)	NR Criteria Considerations:	N/A		
No	8. Utilitarian Structure				
No	9. Sense of Place

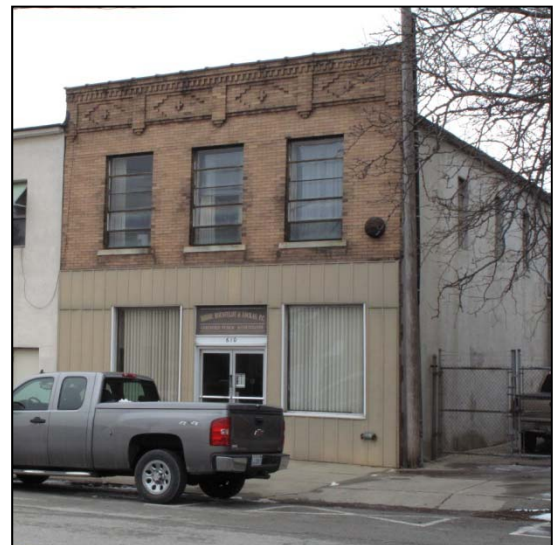
Photo ID: 187

Class:	Building	Condition:	Good	Integrity:	Medium
Yes	1. Heritage value	Individual Eligibility			
No	2. Events (A)	Scope:	Local		
No	3. Persons (B)	NHL:	No	Individual	No
			NR:		
No	4. Architect (C)	District Eligibility			
No	5. Design Elements (C)	District Name:	Ottawa Commercial Historic District		
No	6. Architectural Style (C)	Contributing:	Yes		
No	7. Archaeology (D)	NR Criteria Considerations:	N/A		
No	8. Utilitarian Structure				
Yes	9. Sense of Place

Two-story yellow brick commercial structure with office or dwelling space above first-floor retail. Storefront presents a central entrance flanked by two plate glass windows framed by vertical wooden siding. The second story presents three large windows which seem to have been replaced with metal-framed awning-type windows in the 1900s. Each window has a narrow stone sill and a metal lintel. A large ornate cornice of brick is topped by coping tiles.
