Building Information

Address: No 2 Clinton Street PIN: 21-11-401-019
 Original Owner:
 Building Names: 612 Clinton
 Important Dates: ca 1870
 Architect / Builder:
 Architectural Style: Late Victorian: Italianate

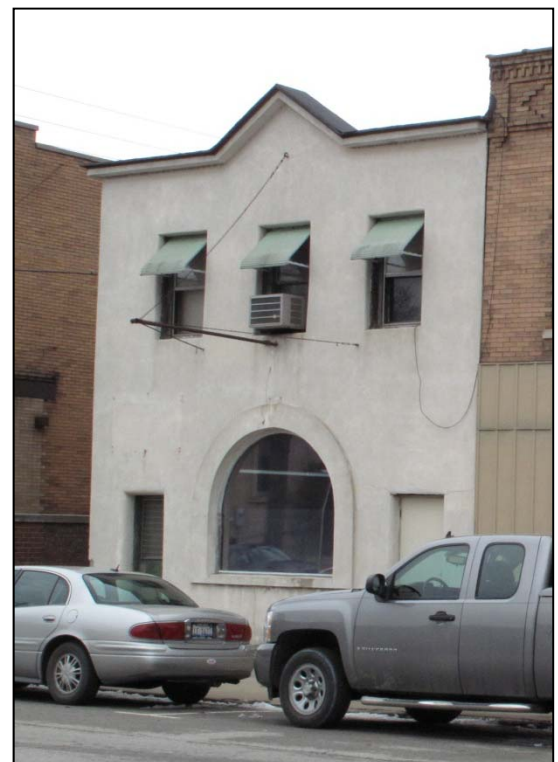
Photo ID: 187

Built as a blacksmith's shop, this building shows typical massing of a late 19th century smithy. The first floor presents a large central arched opening, now a window, flanked by two doors, one leading to the first floor space and one leading to the second floor. Three evenly spaced windows across the second floor façade have rigid awnings of what appears to be a synthetic material. The parapet has a sharply angled pediment in the center of the building. Stucco has obscured the original materials and workmanship of the façade. Was still noted as a blacksmith's shop on the 1913 Sanborn Map.

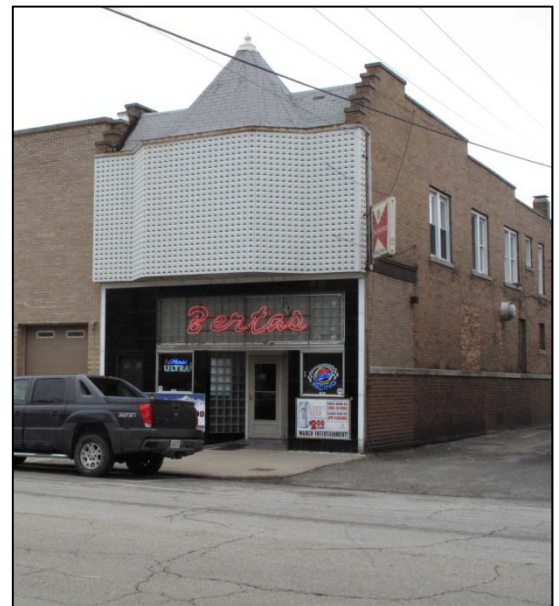
Photo ID: 004

Two story commercial building with second story tower. Storefront replaced with what appears to be black Vitrolite panels and glass block and upper façade covered with molded siding ca 1940.

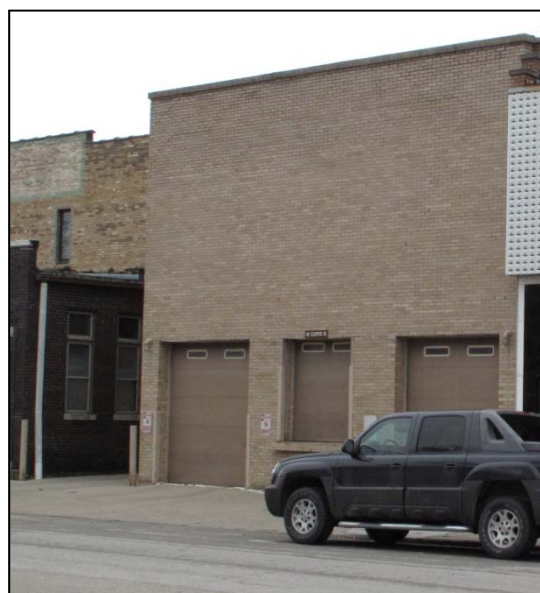
Photo ID: 004

Class:	Building	Condition:	Good	Integrity:	Medium
Yes	1. Heritage value	Individual Eligibility			
No	2. Events (A)	Scope:	Local		
No	3. Persons (B)	NHL:	No	Individual	No
			NR:		
No	4. Architect (C)	District Eligibility			
No	5. Design Elements (C)	District Name:	Ottawa Commercial Historic District		
No	6. Architectural Style (C)	Contributing:	No		
No	7. Archaeology (D)	NR Criteria Considerations:	N/A		
No	8. Utilitarian Structure				
Yes	9. Sense of Place

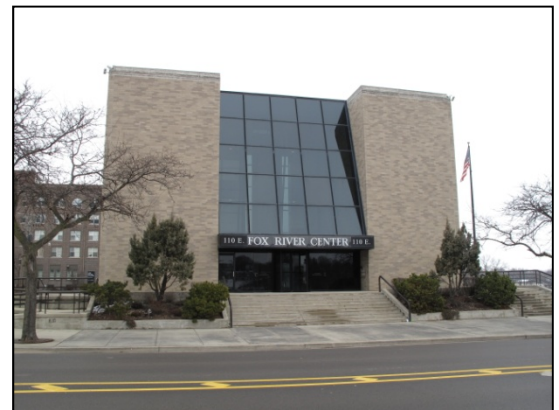
Photo ID: 146

Class: Building Condition: Excellent Integrity: High

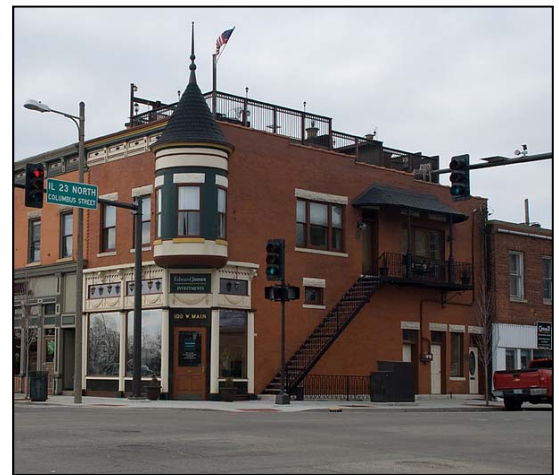
Photo ID: 147

The storefront of this two-story three bay commercial structure has been replaced with a contemporary design that includes elements of the Italianate and Federal Styles. The second floor window treatments, with narrow sills and rusticated heavy lintels, are in keeping with the age of the building and are likely original. A projecting turret at the corner of the second floor has been painted, obscuring the original materials.

The second story with exterior iron stair appears to have been added ca 1895. Façade replaced in 20th century.

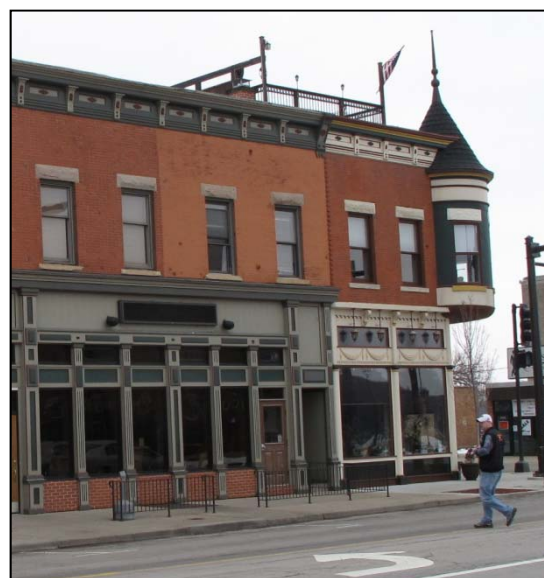
Photo ID: 148

A single contemporary storefront with some traditional design elements extends across the façade of this two-story commercial structure and that of its neighbor. The second story windows have narrow sills and heavy rusticated lintels. The second story windows appear to be contemporary replacements, and the second story façade may have been re-bricked. A wooden cornice with stylized brackets extends across this top of this building and its neighbor.

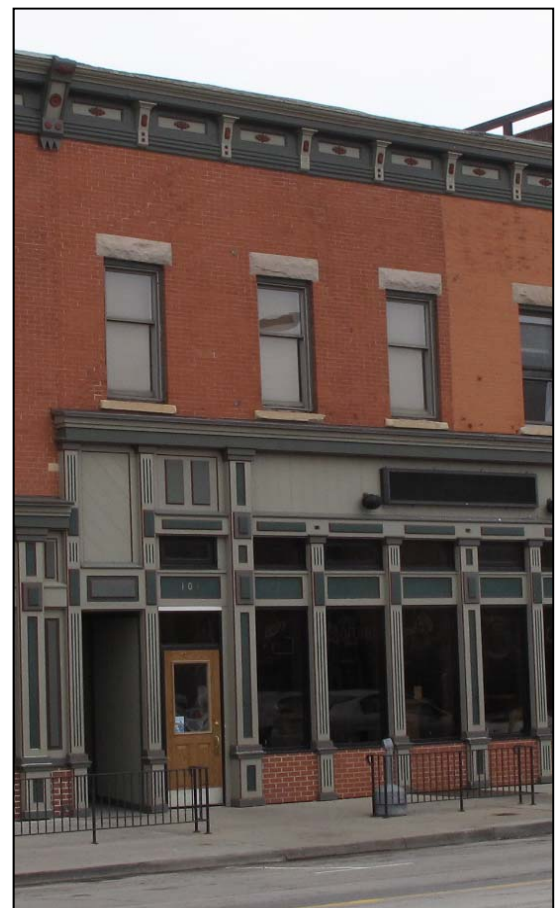
Photo ID: 148

A single contemporary storefront with some traditional design elements extends across the façade of this two-story commercial structure and that of its neighbor. The second story windows have narrow sills and heavy rusticated lintels. The second story windows appear to be contemporary replacements, and the second story façade may have been re-faced with brick. A wooden cornice with stylized brackets extends across this top of this building and its neighbor.

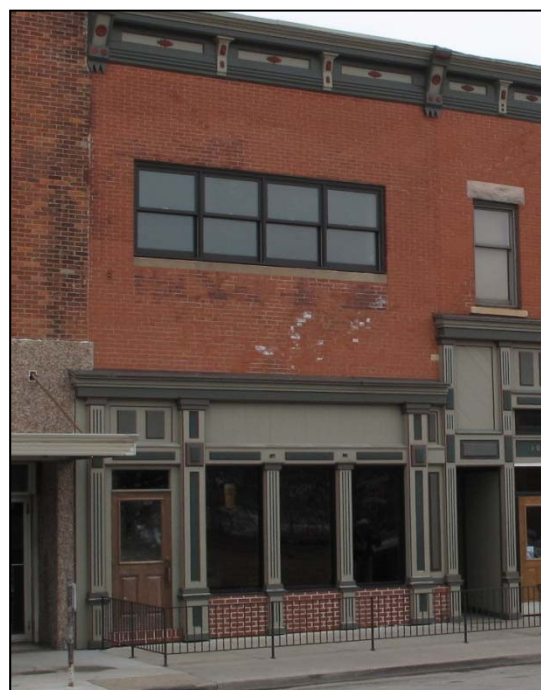
Photo ID: 148

Class: Building Condition: Good Integrity: Medium

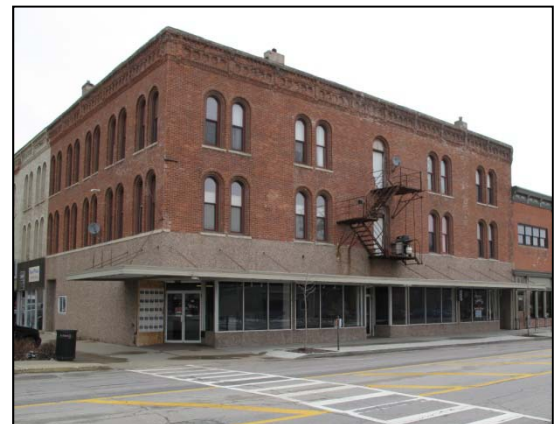
Photo ID: 181

Three-story red brick commercial structure with office or dwelling space above first-floor retail. The storefront has been replaced by a stucco, metal and glass contemporary unit. The second and third floors each present five window bays on each of the façades facing Court and Main Streets. With the exception of the central bay on Main Street, which presents one Roman-arched window on each floor, the remaining bays each present a pair of these windows on each floor. The windows appear to be original; those in the central bay on the Main Street façade have been replaced by doors providing access to a fire escape. An ornate cornice of brick including a sawtooth course, machicolations and the suggestion of brackets decorates the parapet. The cornice and windows tie this building visually to the building north of it on Court Street.

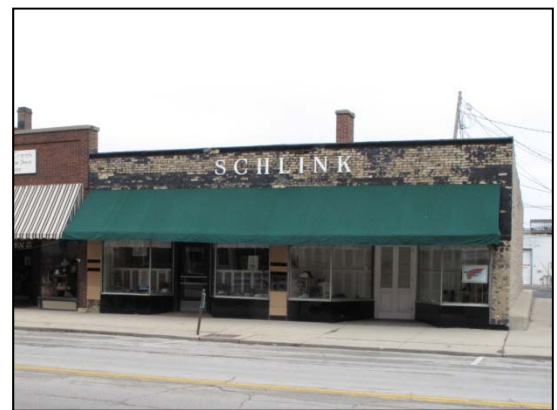
Photo ID: 158

Single story brown brick commercial structure with two store fronts. Remains of tinted structural glass storefront in tan and black remain on portions of the storefront. Other parts of the façade show light-colored brick coated with adhesive from failed structural glass application. A green awning covers much of the façade.

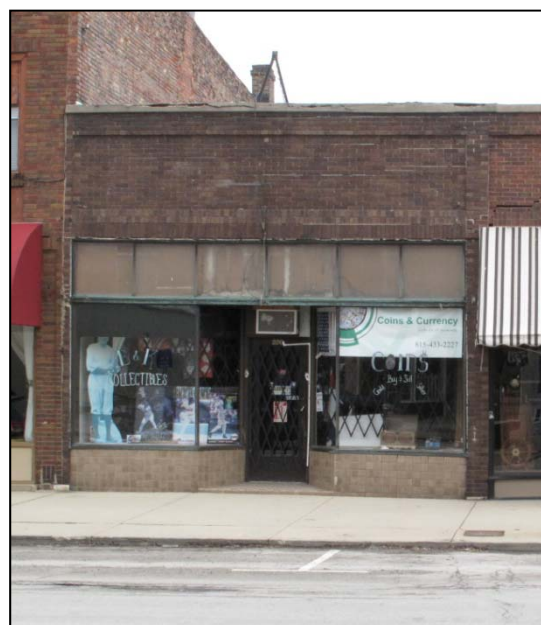
Photo ID: 159

Single story dark brown brick commercial structure. Windows above the storefront appear to be original, though the storefront itself seems to have been recently replaced. Only ornamentation is a recessed panel of brick in parapet wall, similar to those on other buildings in the area.

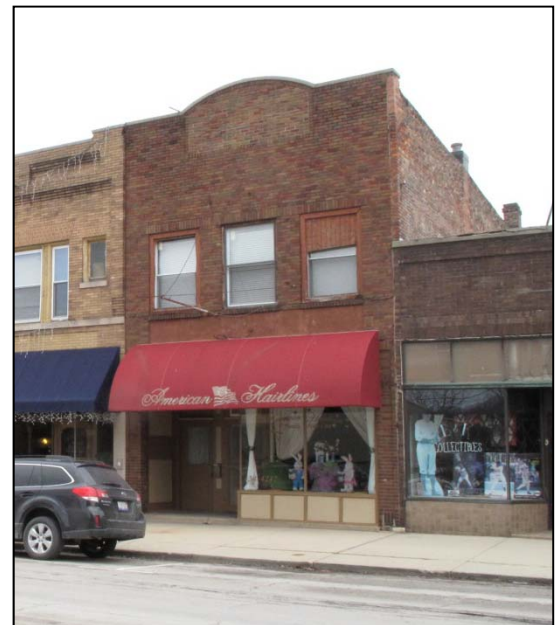
Photo ID: 162

The façade of brown brick appears to have replaced the original façade. The three windows on the second floor are equally spaced across the façade, with sills of brick headers and a single course of soldiers stretching across all three windows as a lintel. Two of the penetrations are partially filled with wood; all three have contemporary double-hung windows. A space in the parapet wall which may have once held a plaque with the building's name has been filled with brick that nearly matches the original, pointed with mortar that is significantly lighter in color

Façade may have been replaced ca 1910, when the building was expanded in the rear to the alley to provide warehouse space. It served as a feed and grain store from the 1880s into the 1920s.

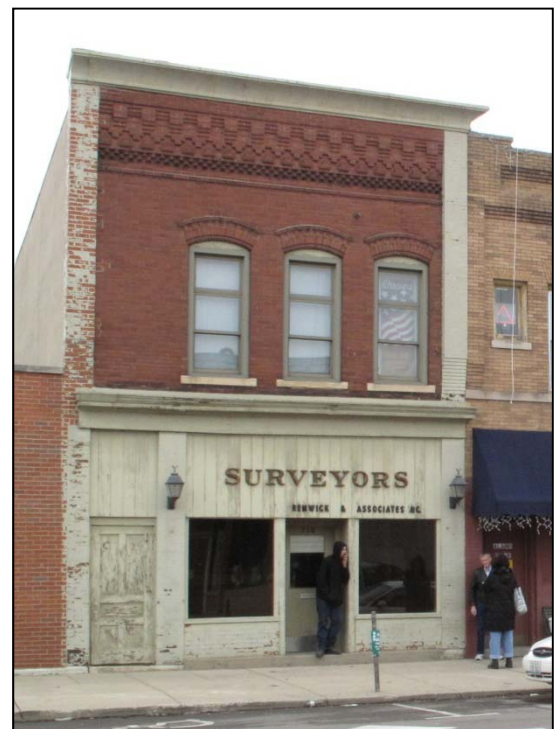
Photo ID: 163

Two-story red brick commercial structure with office or dwelling space above first-floor retail. The storefront has been replaced with a wood and brick structure with two plate glass windows and a doorway in a very shallow recess. The door to the second floor is situated at the west end of the façade; the transom has been filled with the same wooden siding used on the storefront.

The second floor is separated from the first by a projecting cornice that appears to be painted metal. Above this are four bays. Those above the storefront each present a single window with a stone sill and segmental arch of brick laid in sawtooth patterns. The windows are contemporary replacements. The remaining bay about the second-floor entry is blank.

Above the windows, the pediment is decorated by a complex pattern of brick, features courses of projecting stretchers, sawtooth headers, and complex machicolations. Four courses of stretchers separate this exuberant brickwork from a simple metal cornice at the top of the parapet.

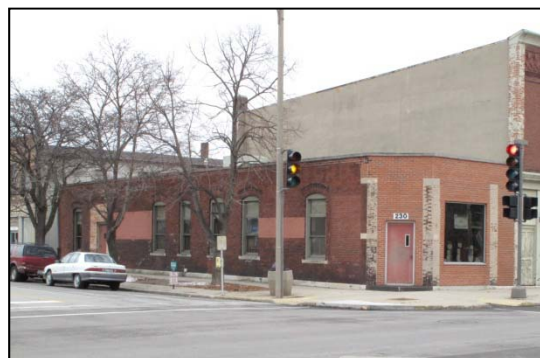
Photo ID: 165

Ground floor of what had been a two-story building in red brick. The Main Street façade has been completely replaced with plain red brick. The Clinton Street façade maintains the original window penetrations with ornate brick segmental arches composed of alternating rows of sawtooth soldiers and headers, similar in design to the neighboring building. Windows have been replaced with contemporary double-hung units with a fixed opaque panel above. Near the rear of the building, a large penetration originally used for a doorway has been filled with brick and a narrow contemporary door.

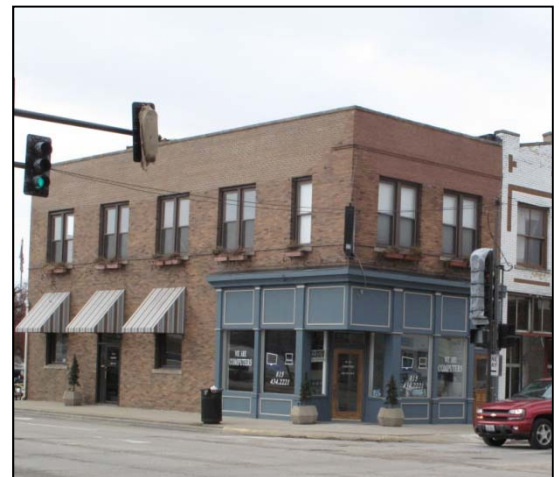
Photo ID: 151

Two-story brown brick commercial structure with office or dwelling space above first-floor retail. Storefront with corner entry has been replaced by contemporary wood and plate glass unit. Wooden doors appear to date from the building's construction. A third entrance on LaSalle Street has been replaced by a contemporary metal and glass commercial entry. Windows on either side of this doorway have stone sills. The second floor windows which appear to be contemporary replacements, are arranged in pairs, each grouping having a similar sill. The only ornamentation on the parapet is a two-course line of corbelled stretchers about a third of the way between the second-story windows and the stone coping on the parapet. This decorative course extends across the Main Street façade, and wraps around the LaSalle street façade for approximately three feet. Repair to the parapet on the LaSalle Street façade used mortar and tooling that does not match the original.

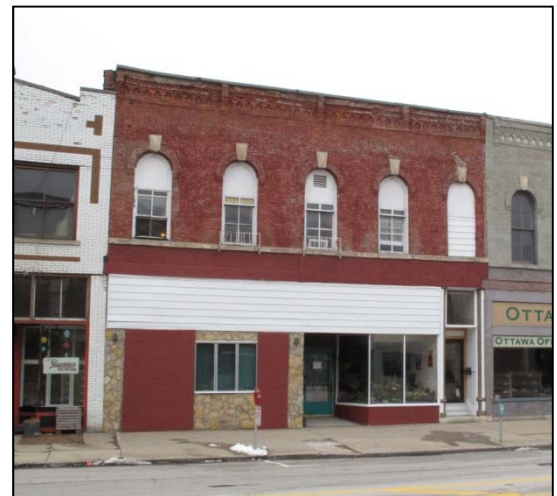
Photo ID: 182

Two-story red brick commercial structure with office or dwelling space above first-floor retail. Storefront has been extensively changed, presenting a variety of materials, including contemporary wood and metal siding, faux stone veneer, and painted brick. An entry to the second floor is located on the west side of the storefront. Second floor presents five windows with roman arches. The western-most penetration has been filled with wood and metal siding. The lower sashes of the remaining windows appear to be original, though the upper sashes have been replaced or filled with wood. The windows have brick window hoods with oversized keys, similar to other buildings in the area and its neighbor. A complex brick cornice also similar to those found throughout the downtown area finishes the wall.

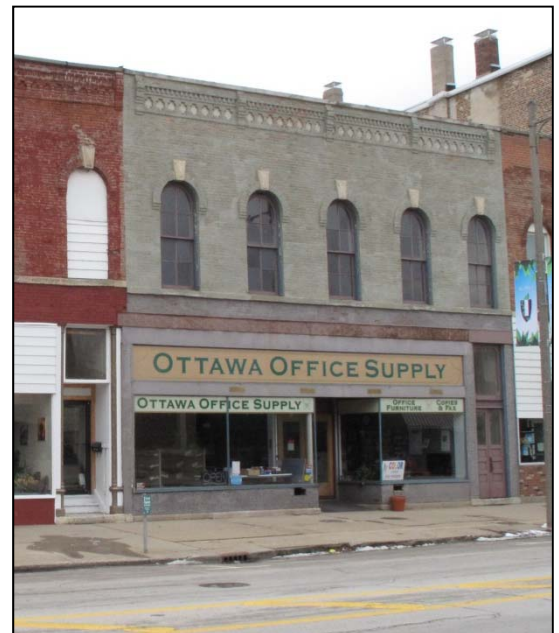
Photo ID: 182

Two-story red brick commercial structure with office or dwelling space above first-floor retail. Storefront has recessed central entry with plate glass windows. An entry to the second floor is located on the west side of the storefront. Storefront doors appear to be original. Second floor presents five windows with roman arches. Windows appear to be original, and have brick window hoods with oversized keys, similar to other buildings in the area. A complex brick cornice also similar to those found throughout the down town area, finishes the wall. The second story brick has been painted, which may be contributing the spalling evident near the cornice.

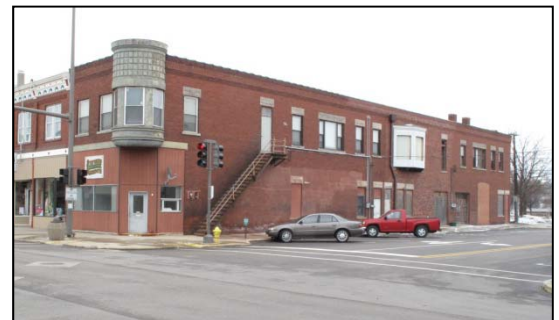
Photo ID: 166

A second-floor turret on at the corner of the building and an Oriole window mid-way down the Clinton Street façade are the most prominent features. All penetrations but one have been retained. This is a tall opening presumably for carriages or warehouse loading, near the south end of the Clinton Street façade. Most of the windows and doors have been replaced, but other material, including a simple cornice of corbelled brick and coping tiles with exaggerated overlapping ends, have been maintained.

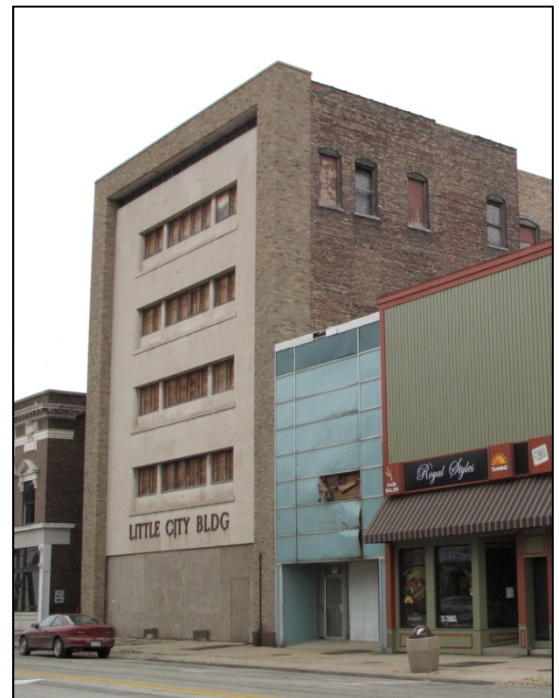
Photo ID: 120

This façade of this five-story masonry structure was remodeled in the 1950s using elements of the International Style—particularly the strong contrast between the vertical brick panels at either end of the building with the horizontal ribbon windows. The windows are currently boarded up from the inside and the storefront covered in plywood.

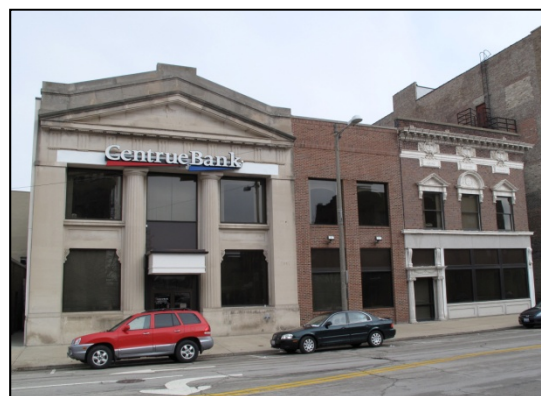
Photo ID: 122

This building presents three separate facades. The central façade is a two-bay, two-story contemporary brick façade with contemporary plate glass windows. To the left is a turn of the century classical revival temple-front bank, with the three bays marked by two engaged Doric columns and two plain pilasters at the building corners. These support a simple entablature, above which is a classical pediment with plain tympanum. The building to the right takes its design influence from the Italian Renaissance Revival Style, with a simple storefront surmounted by three second-floor windows with ornate white terra cotta hoods, and above those a cornice incorporating three cartouches and the construction date, 1902. Above the cartouches is a second bracketed cornice, then a plain brick entablature with plain coping stones completing the parapet.

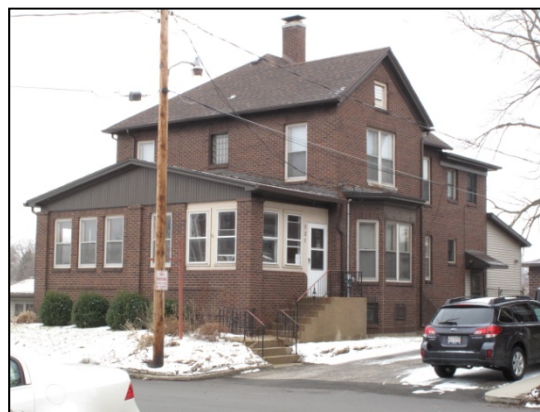
Photo ID: 053

Plan: Irregular Stories: 2.5
 Roof Type: Hip
 Foundation:
 Walls: BRICK
 Sheathing:
 Windows: Double-Hung, Glass Block
 Doors:
 Trim: WOOD
 Roofing: ASPHALT
 Flashing: METAL
 Chimney: BRICK

Class:	Building	Condition:	Good	Integrity:	Medium
Yes	1. Heritage value	Individual Eligibility			
No	2. Events (A)	Scope:	Local		
No	3. Persons (B)	NHL:	No	Individual	No
			NR:		
No	4. Architect (C)	District Eligibility			
Yes	5. Design Elements (C)	District Name:	Ottawa Commercial Historic District		
Yes	6. Architectural Style (C)	Contributing:	Yes		
No	7. Archaeology (D)	NR Criteria Considerations:	N/A		
No	8. Utilitarian Structure				
Yes	9. Sense of Place

A two-story domestic structure in brick with a hip roof including a front gable and a front gable roof on a sizable one-story dependency extending from the north façade. The dependency, apparently once a sunroom and porch has been completely enclosed and its roof has been replaced. The rest of the building appears to have retained its integrity of materials and design, with the exception of the application of glass block on a small window on the second floor.

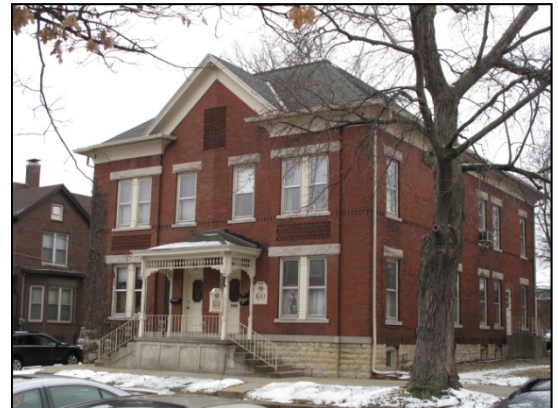
Photo ID: 054

Address:	111-113 East Jefferson Street	PIN:	21-11-248-010	Plan:	Rectangular	Stories:	2.5
Original Owner:		Roof Type:	Hip	Foundation:			
Building Names:		Walls:	BRICK	Sheathing:			
Important Dates:	ca 1890	Windows:	Double-Hung	Doors:	METAL, GLASS		
Architect / Builder:		Trim:	STONE	Roofing:	ASPHALT		
Architectural Style:	Late Victorian: Romanesque	Flashing:		Chimney:	BRICK		
Historic Function:	DOMESTIC: multiple dwelling						
Current Function:	COMMERCE: professional						
References:	Estimated construction date based on 1888 and 1891 Sanborn Maps.

Class:	Building	Condition:	Good	Integrity:	High
Yes	1. Heritage value	Individual Eligibility			
No	2. Events (A)	Scope:	Local		
No	3. Persons (B)	NHL:	No	Individual	Yes
		NR:			
No	4. Architect (C)	District Eligibility			
Yes	5. Design Elements (C)	District Name:	Ottawa Commercial Historic District		
Yes	6. Architectural Style (C)	Contributing:	Yes		
No	7. Archaeology (D)	NR Criteria Considerations:	N/A		
No	8. Utilitarian Structure				
Yes	9. Sense of Place

A two-story two-family domestic structure in brick with a hip roof including a front gable. A foundation of rusticated yellow stone supports a watercourse of tooled grey stone. The remainder of the building is red brick. The main façade divides into five bays, with the central bay presenting two entries sheltered by a hipped roof supported by turned pillars. The porch roof appears to be supported by a cornice of spindles supported by scrollwork brackets. Above the porch are two windows, each with a narrow smooth stone sill and a very heavy lintel of rusticated stone. Above the windows in the central bay is a rectangular panel of sawtooth masonry which extends into the pediment formed by a wide plain wooden cornice.

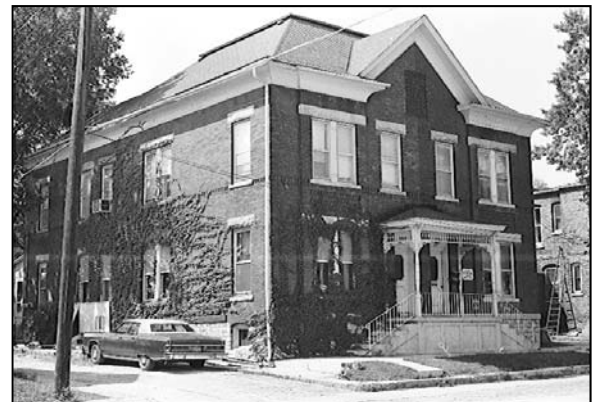
Photo ID: HAARGIS Photo

The bays on either side of the entry protrude slightly from the plane of the wall. On the first floor, these bays present a pair of double-hung windows divided by a wooden panel carved to mimic the porch posts. Like the windows in the central bay, these have a narrow sill of tooled stone. The lintels of these windows are of heavy rusticated stone that stretches across the entire bay. Suggesting a spandrel panel between the first and second floor windows is a rectangle of sawtooth masonry. The treatment of the second floor windows is identical to those on the first floor. The cornice is repeated above these projecting bays, and form a return on either side of the pediment. The remaining bays are narrow brick walls interrupted only by a change in the bond at the level of the second story window sills. That band continues around the entire building, and the window treatments, including the heavy stone lintels, are continued throughout as well.

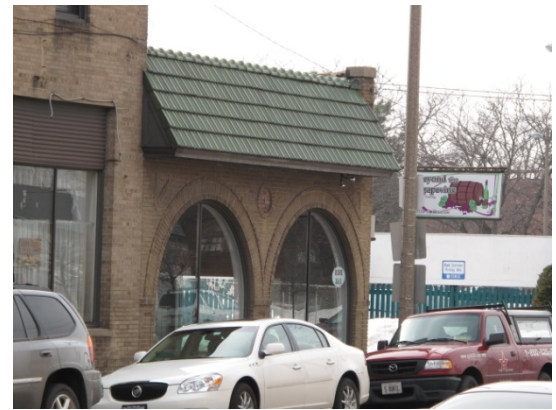
Photo ID: 059-1

Plan: Rectangular Stories: 1
 Roof Type: Flat
 Foundation:
 Walls: BRICK
 Sheathing:
 Windows: Plate Glass
 Doors: METAL, GLASS
 Trim:
 Roofing: CLAY TILE
 Flashing:
 Chimney:

Class:	Building	Condition:	Good	Integrity:	High
Yes	1. Heritage value	Individual Eligibility			
No	2. Events (A)	Scope:	Local		
No	3. Persons (B)	NHL:	No	Individual	Yes
		NR:			
No	4. Architect (C)	District Eligibility			
Yes	5. Design Elements (C)	District Name:	Ottawa Commercial Historic District		
Yes	6. Architectural Style (C)	Contributing:	Yes		
No	7. Archaeology (D)	NR Criteria Considerations:	N/A		
No	8. Utilitarian Structure				
Yes	9. Sense of Place

This Spanish Colonial Revival storefront in brick presents Roman arched windows and a green tile roof.

Similar in style to a garage built at 1012 LaSalle during the same period.
