Building Information

Address: 800 LaSalle Street PIN: 21-11-241-004
 Original Owner:
 Building Names: Montgomery Ward
 Important Dates: 1938
 Architect / Builder:
 Architectural Style: Revivals, Late 19th / Early 20th C: Colonial Revival
 Historic Function: COMMERCE: department store
 Current Function: COMMERCE: department store
 References: Construction date per Sesquicentennial, p. 74.

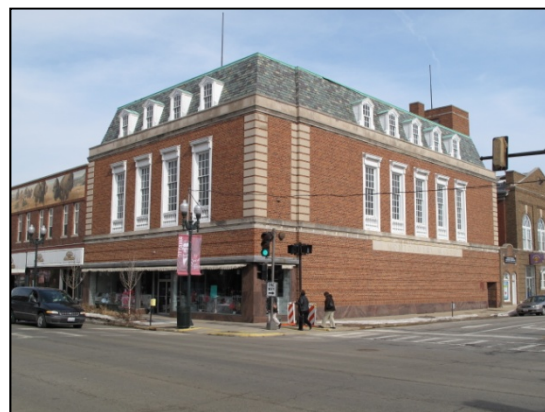
Photo ID: 087

A simple granite first floor storefront façade gives way to Colonial Revival architectural design on upper floors. Tall, 12 over 16 double-hung windows spanning multiple floors, the use of quoins and the string courses of stone marking the divisions between floors are all characteristic of the style. In a departure from the historical style but common to buildings in the Revival Style, the building is topped with a slate mansard roof with dormers. The south façade includes a limestone panel engraved with the store's name.

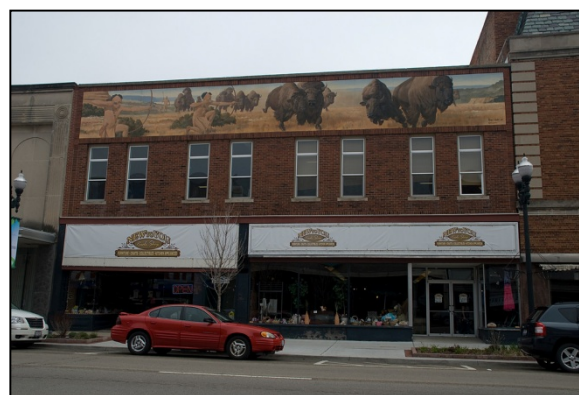
Photo ID: 104

A simple commercial structure in brown brick presenting four pairs of double-hung windows across the second floor. Ornamentation is limited to three strings of rowlocks (one between the first and second floors, one above the second floor windows, and one at the top of the parapet). The area above the second floor windows has been used for a mural depicting Indians hunting buffalo on the plains.

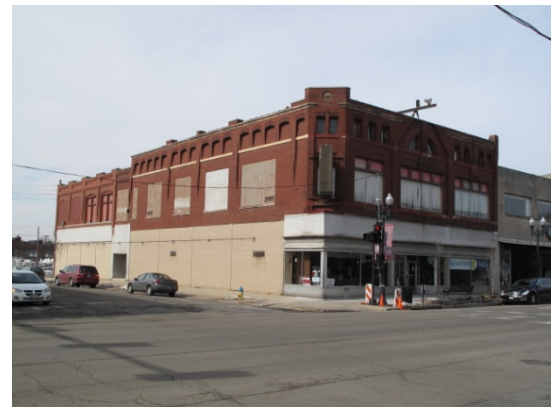
Photo ID: 113-1

Red brick two-story commercial structure with residential or office space above. The original first floor storefront façades have been completely replaced along both LaSalle and Jefferson Streets. However, the second floor masonry is in very good condition. Original large window penetrations have been retained, and the original windows in the LaSalle street façade appear to be in place. Ornate brick work around the third floor windows and cornice remain in place, though pediments formerly extending above the parapet have been removed. A carved or cast rosette decorated the top of the parapet at the corner of the building.

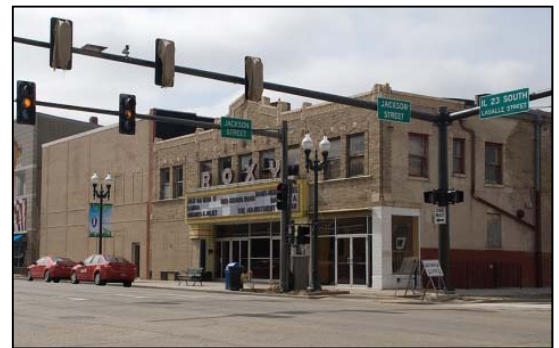
Photo ID: 090

The façade of the southern portion of the building has been recently replaced by a plain buff brick wall with a single contemporary door.

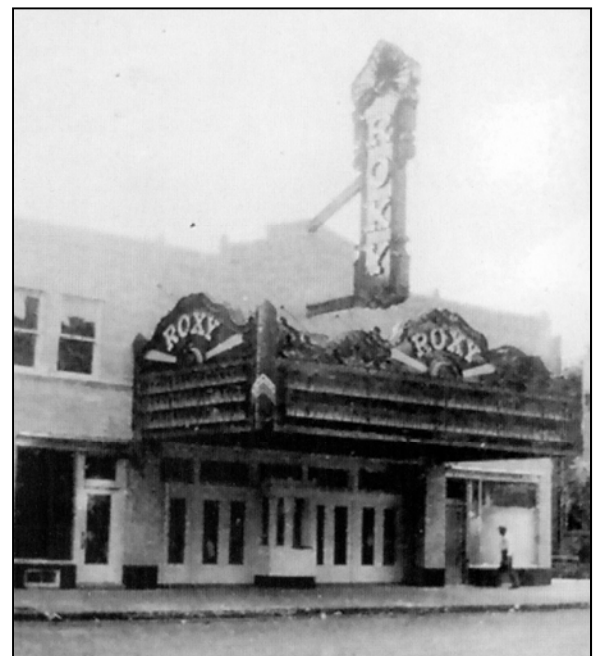
Photo ID: Ottawa016

A façade of buff brick with exuberant Art Deco designs executed in terra cotta, the Roxy Theater is one of the few examples of the style in Ottawa. As with most buildings in the Commercial District, the second story façade is practically unchanged, including chevron-laden terra cotta coping and angled brick work with terra cotta details above the second story windows. It appears that the theater originally had a vertical sign centered above the entrance, as mounting hardware is in evidence above the windows. As with many theaters of the period, the central theater entrance was flanked by two storefronts. The theater entrance has been replaced with contemporary metal and glass doors and windows, and a flat marquee mounted above the entrance. The storefront to the south has been completely bricked over, retaining only a first-floor cornice of terracotta and some of the fabric associated with the original storefront at ground level. The storefront to the north has been completely replaced with contemporary windows and doors.

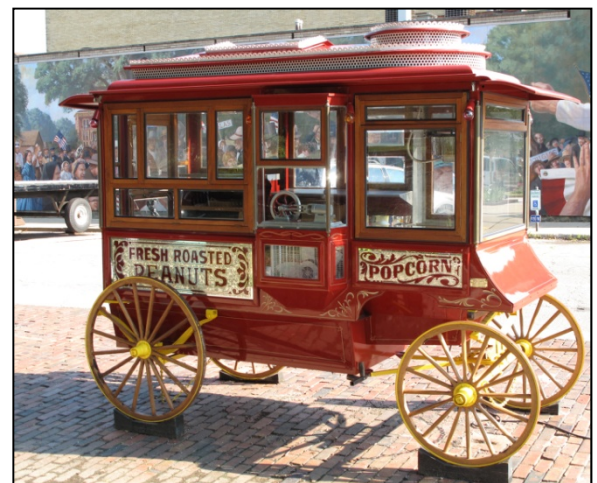
Photo ID: 215_1

A carriage of glass and red-enameled wood and metal stands at the corner of Jackson and LaSalle Streets near Washington Park each summer. The vehicle has undergone some modifications since the HARGIS photo was taken ca 1975.

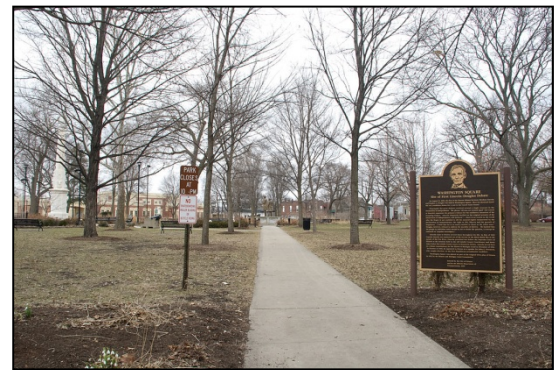
Photo ID: 210-1

Washington Square is a block of parkland which is a contributing element to the Washington Park Historic District. The park was the location of the first Lincoln-Douglas debate on August 21 in 1858. It is also the site of a civil war monument and of a fountain commemorating the debate.

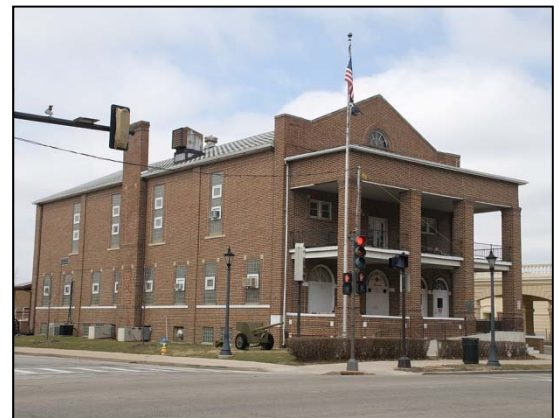
Photo ID: 091

The secondary facades present tall, regularly spaced windows on both the first and second floors. These have all been replaced with glass block. Recent pointing did not maintain the original mortar profiles, detracting from the building's appearance.

The porch beneath provides access to the building. Three entries are evenly spaced across the façade. The central entry and the one to its left each consist of a double door surmounted by a fan light. The right-side entry consists of two separate doorways, each topped by a separate fan light. Instead of a metal railing, the first floor porch is enclosed by a masonry wall approximately 3 feet high. This wall is interrupted by an opening in front of the right-hand entries which allows access to the porch from a ramp leading to the street.

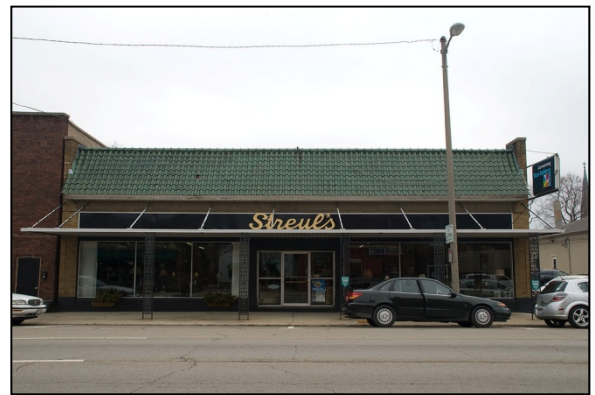
Photo ID: 095

Single-story yellow brick commercial structure has a distinctive green tile mansard roof. The storefront appears to have been replaced in the 1940s, including black panels, expanses of plate glass and a slender canopy protecting the entire building front, periodically supported by wrought iron supports with foliate patterns.

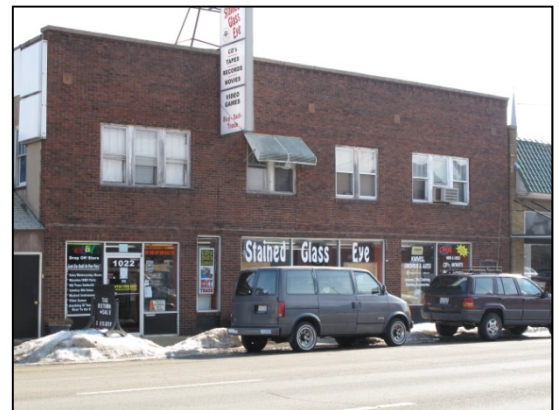
Photo ID: 096

A simple, unadorned red brick commercial structure with office or residential uses above presents a plain façade and original three-over-one second-story windows. Although the first floor windows and doors have been obviously replaced, the original penetrations seem to have been maintained. The only ornament on the building is the barely-noticeable machicolations formed by the last four courses of brick beneath the coping stones of the parapet. An aluminum and fiberglass awning and a large lighted sign intrude on the building's façade, but both features can easily be removed, and therefore are not considered in determining the building's integrity.

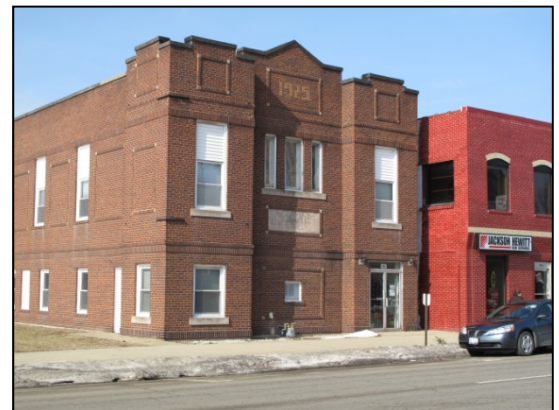
Photo ID: 094

Built in 1925 as a Salvation Army Citadel, this building of dark brown brick presents design elements common to the commercial style popular in the early 20th century. Simple masonry elements, including squares of cast stone and soldier and rowlock courses of brick serve as decorative elements. Although windows have been replaced the original penetrations have been maintained.

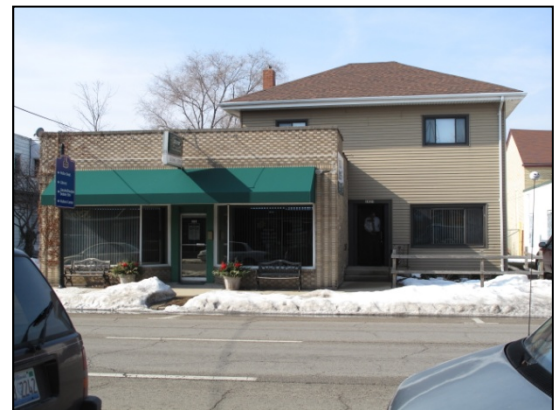
Photo ID: 097

Although the buildings are clearly connected, because of the level of integrity of the storefront, the building as a whole will be considered contributing. Likewise, condition and integrity statements are based on 1019, not 1021.

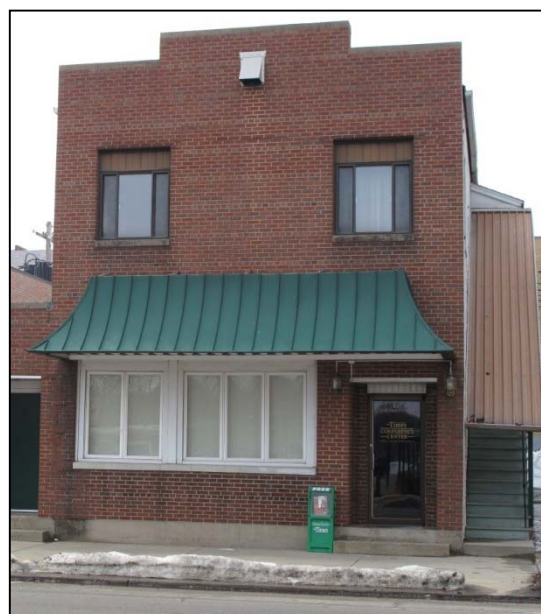
Photo ID: 013

Simple brick façade on this two-story building added in the late 20th century. A metal mansard-type hood stretches across the front of the building over the first-floor doorway and windows. Windows have been replaced on the first and second floors. The north side of the building maintains examples of the original windows and shutters.

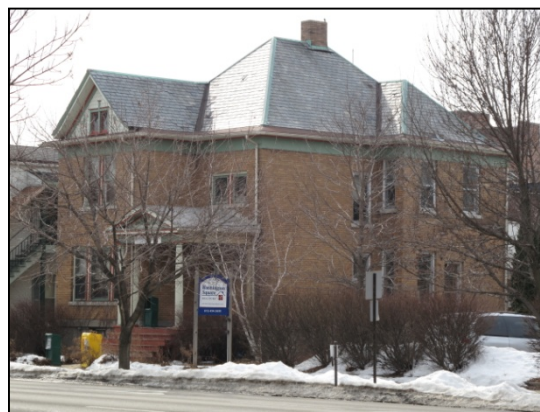
Photo ID: 037

Fine example of a brick Queen Anne home appears to have retained all its significant features except for the cornice, which has been replaced by a wide plain band of wood or metal. Windows and doors, porch roof with supporting columns and pediment and copper flashing on the slate roof all appear to be original. The brick work laid in a plain stretcher bond and including a distinctive exaggerated angled pattern above the windows on the main façade, suggest that brick veneer was a later addition to the original frame construction.

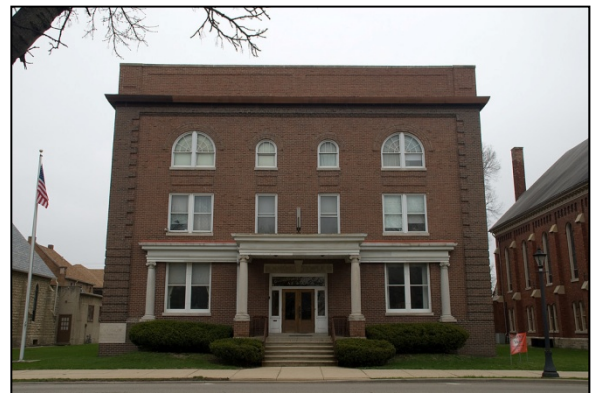
Masonic Temple shows the application of Renaissance Revival stylistic characteristics to a simple brick structure. The building presents four bays, two of which join on the first floor to accommodate the main entrance. A flat-roofed portico over the main entrance is supported by simple Ionic columns on brick plinths. The heavy entablature of the portico continues along the front of the building, forming hoods over the windows in the remaining bays. The entablature is supported by pilasters and brick plinths on either end. Other renaissance revival motifs expressed in this building include the suggestion of quoins at the corners of the building, the regular window placement across the main façade, the use of arched windows on the top floor with bricks outlining the suggestion of spandrel panels between the floors. Finally, a heavy metal cornice and simple parapet cap the building's main façade.

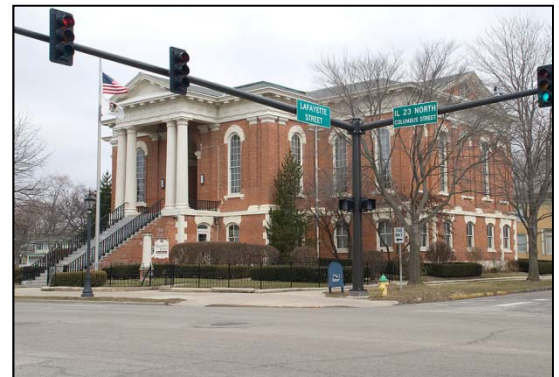
Photo ID: 040

The design of this brick court house borrows heavily from both the Classical and Colonial Revival Styles. The use of red brick as the primary building material, pilasters to define the window bays, the elevated main floor and use of quoins are all colonial motifs. The prominent portico with simple fluted columns, entablature consisting of cornice, frieze and architrave, and pediment are all strongly classical design features commonly applied to public buildings during this period. The entablature encircles the entire building, with the use of the pediment repeated on all elevations, and the classically-inspired Roman arch is applied to all windows on the main floor, while the more common segmental arch is used on the lower floor windows.

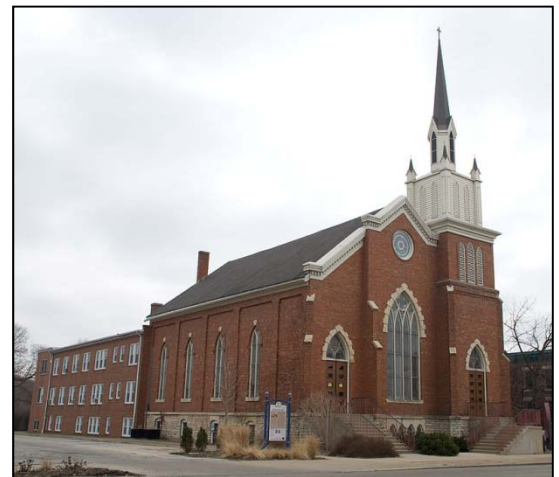
Photo ID: 052

The First Presbyterian Church presents a Victorian church design that borrows liberally from the Gothic and Classical traditions. Gothic features include reliance on lancet windows and the pointed arch. Other Gothic features include the use of stone-capped buttresses, the steeply pitched roofs and steeples. A classically-inspired cornice appears on the gable ends; the shape of the exaggerated cornice dentils are repeated in the multiple keys decorating the stone hoods of the windows. A wooden tower top with gothic details was added some time after the 1972 landmarks survey, which shows the tower unfinished.

To the rear of the church is a three-story 1929 addition in red brick that also maintains excellent integrity. Tower completed after 1972.

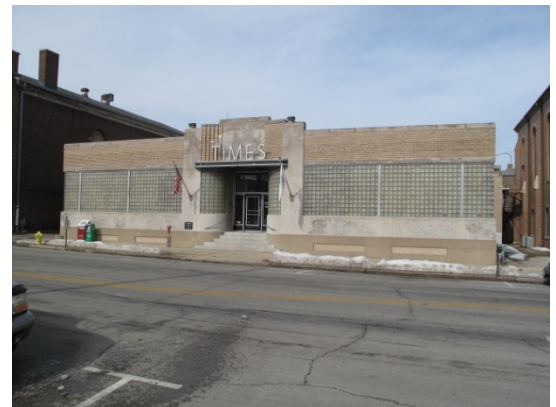
Photo ID: 056

A symmetrical Art Deco building of brick and stone presents strong horizontal lines: First, a low foundation in concrete, then a course of smooth stone, then glass block windows topped by a string course of stone and a brick parapet with stone coping. The horizontal lines of the building are interrupted by the central entry, marked by the suggestion of limestone pilasters on either side. Curved glass block visually leads into the recessed entryway which maintains its original doors and fenestration. A simple flat awning covers the entry, above which the name of the paper stands in bold aluminum letters. The stone pilasters extend above the parapet, and between them courses of brick in stacked bond raked back towards a central expanse of limestone. Typical of the style, the pilasters, brick work and central stone expanse are of varying heights, creating a stair-step effect above the entry.

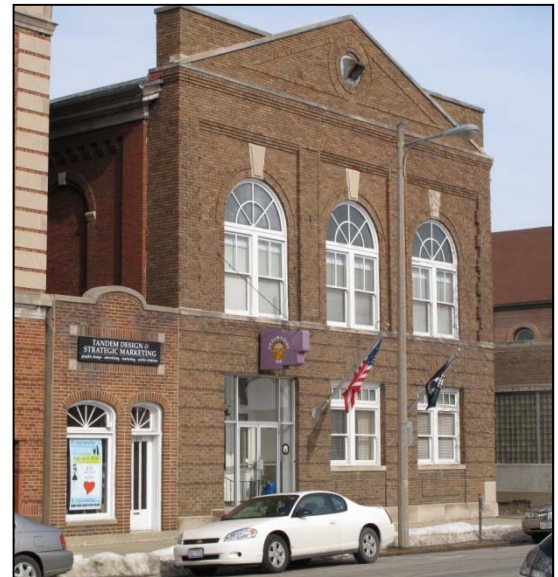
Photo ID: 057

HAARGIS No. 124617
 A three-bay classically-inspired façade of brown brick dates from 1912. This façade includes a simple pediment enclosing a broken pediment and roundel in brick. The second story bays each present a pair of double-hung windows surmounted by a fan light. Each of the resulting Roman-arches has an exaggerated keystone. A narrow string course of stone separates the second story from the first. The left-hand bay on the first floor presents an entryway of contemporary metal and glass, while each of the other two bays present a group of two double-hung windows arranged beneath a transom. The first floor bond pattern makes use of regularly-spaced courses set back from the wall's edge. The resulting visual effect suggests oversized masonry commonly used for the ground floor of classical buildings. Windows are original to the 1912 renovation. A portion of the west façade of the building is visible over the adjacent building and presents a wall of red brick with simple machicolations beneath a wooden cornice and an arched window opening with keystone, suggesting a much earlier initial construction

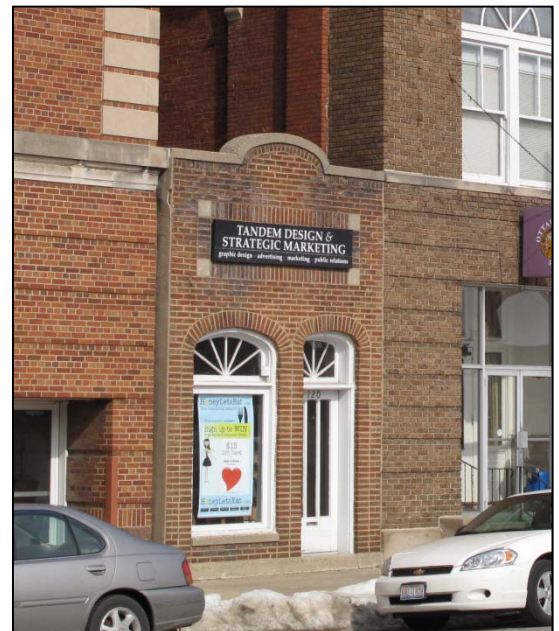
Photo ID: 057

A narrow, single-story storefront of brown brick with segmental arches over a single plate-glass window and door. The shape of these two arches, each of which holds a fan light, is repeated in the treatment of the parapet.

Served as a barber shop.

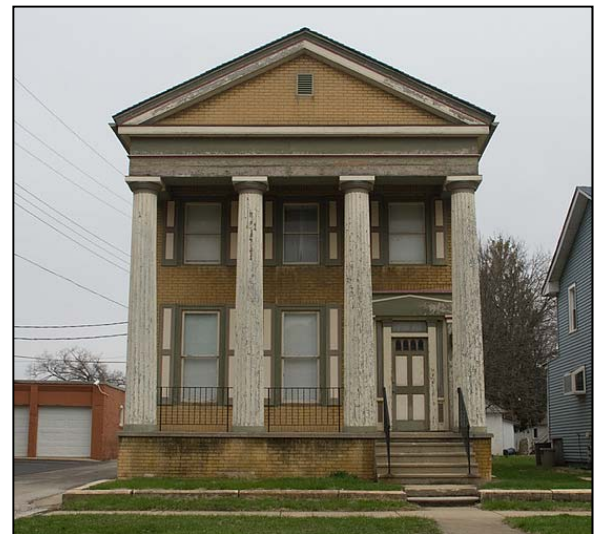
Photo ID: 060

Built by an early merchant of Ottawa who harbored runaway slaves. Stands within the boundary of the Washington Park Historic District, but is not listed as a contributing element and also does not contribute to the Commercial District.

Per Ottawa's Sesquicentennial--1837 to 1987, Section 9, Page 14, John Hossack House actually stood across the river in South Ottawa.

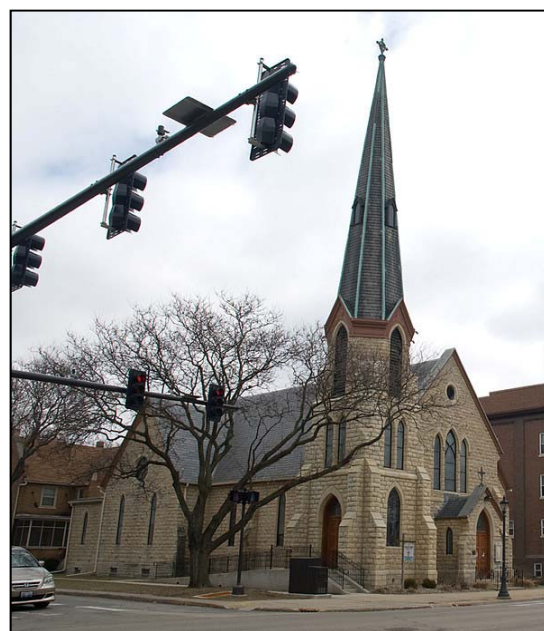
Photo ID: 061

HAARGIS No. 124474

Christ Episcopal Church is built in the Gothic Revival Style popular during the 19th century. Common Gothic design elements inform the structure, from the steeply-pitched gable-front roof, to the narrow lancet windows repeated use of the Gothic arch, buttresses with angled stone caps, and the copper-flashed tower roof and later alterations in 1881 - 1884.

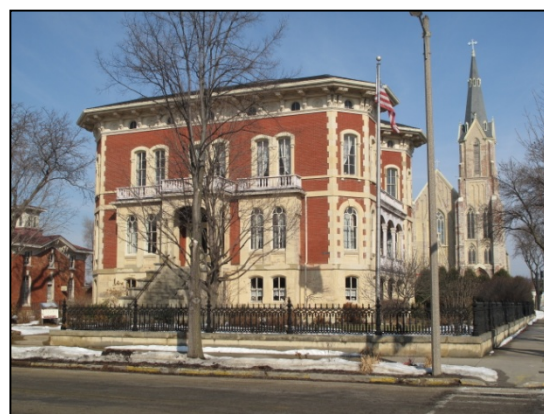
Photo ID: 062-1

HAARGIS No. 124473

Built as his home, William Reddick's mansion is a grand expression of the mid-19th century conception of the Italian Villa. From the shallow hipped roof supported by ornate corbelled brackets attached to a broad cornice, to the heavily-hooded segmental arch windows on the second floor, a series of second-floor balconies and the contrast of deep red brick with buff-colored stone, the building has long been considered an important architectural resource.

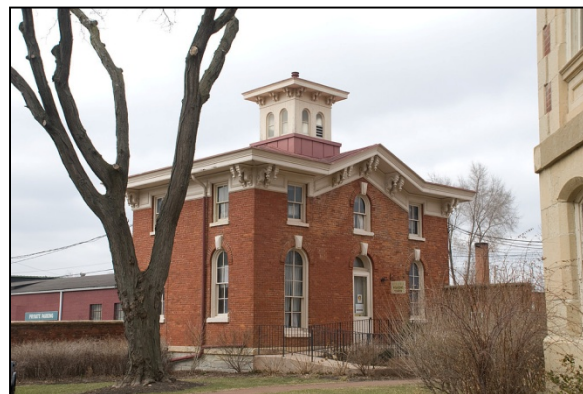
Photo ID: 062-2

Includes a contributing two-story outbuilding, also with Italianate design features.

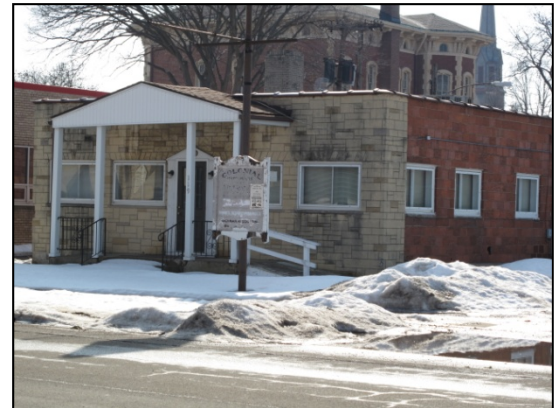
Photo ID: 204

A small single-story building of clay masonry block with a random ashlar patterned stone veneer on the main façade. That façade also presents a shallow porch with pediment supported by narrow piers. The design of the porch is not consistent with the building's original design, and the application of stone veneer and installation of replacement windows further detracts from the building's integrity.
