### Building Information

Address: No address 1	PIN: 21-11-218-001	Plan: Rectangular	Stories: 2
Original Owner:		Roof Type: Flat	
Building Names: Marquette School		Foundation:	
Important Dates: ca 1955		Walls: BRICK	
Architect / Builder:		Sheathing:	
Architectural Style: Modern Movement: Modern, General		Windows: Plate Glass, Awning-Style	
		Doors: METAL, GLASS	
Historic Function: EDUCATION: school		Trim: METAL	
Current Function: EDUCATION: school		Roofing:	
References:		Flashing:	
		Chimney:

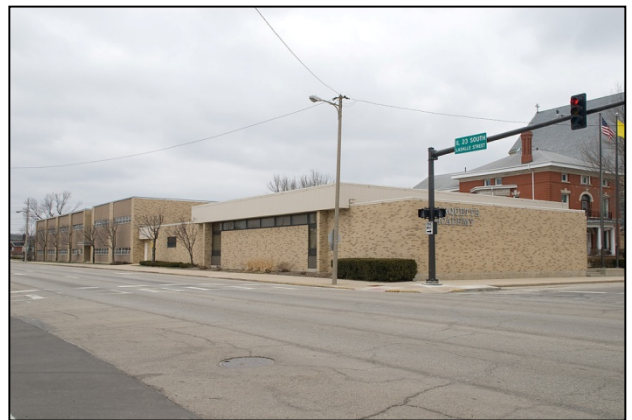
Photo ID: 188

Good example of the International Style presenting many of the style's common elements: ribbon windows prominent glass entryways, and contrasting brick emphasize the horizontal and vertical features on different portions of the north façade.

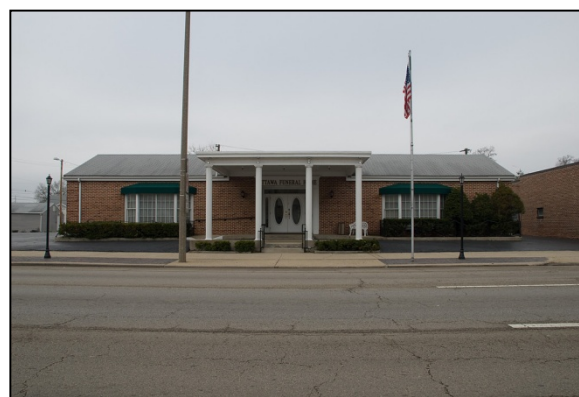
Photo ID: 101

Simple single-story brick structure with details reminiscent of the Colonial Revival Style: the suggestion of a classical entrance pavilion with white columns and pediment. White pilasters decorate the secondary (south) Brick façade and colonial treatment may have been added after original construction.

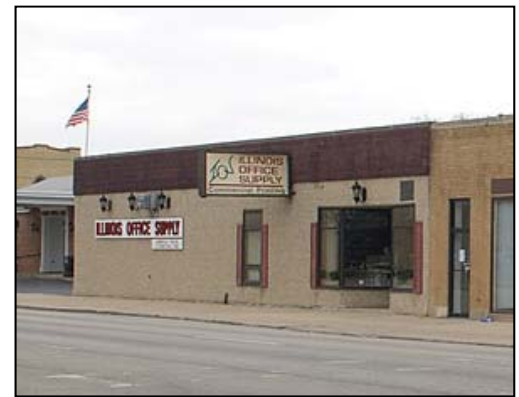
Photo ID: 102

Constructed as a print shop, the building is now faced with stucco and brick. Contemporary aluminum windows with lower hopper units are flanked by narrow shutters. Four colonial-style wall lanterns are affixed to the wall.

Stucco, windows and lanterns are all later additions.

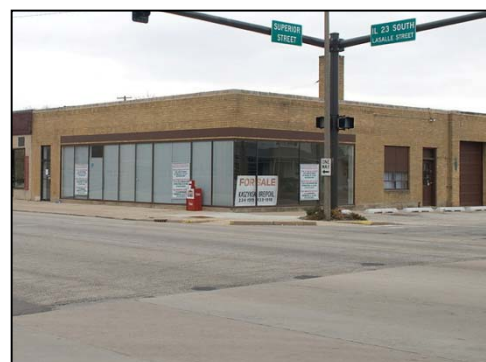
Photo ID: 102

Single-story building constructed as an auto sales and service building of brown brick. Decorative courses of brick, 3 soldiers alternating with three stacked stretchers, suggest a cornice. Windows and doors have been replaced but the original profiles and penetrations have been retained.

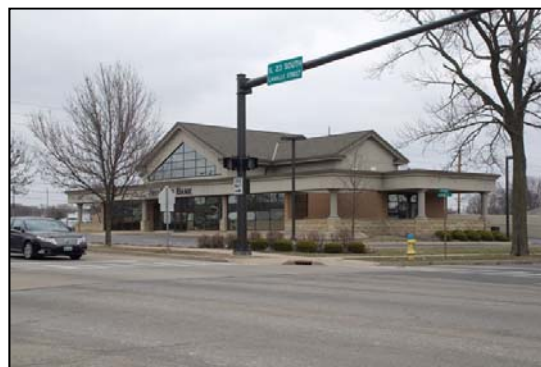
Photo ID: 189

Contemporary rectangular bank building of brick, stucco and glass with prominent cross-gable roof. The majority of the curtain wall on the main (west) façade is glass. Central entryway and cornice above are slightly curved.

Building too new to be contributing.

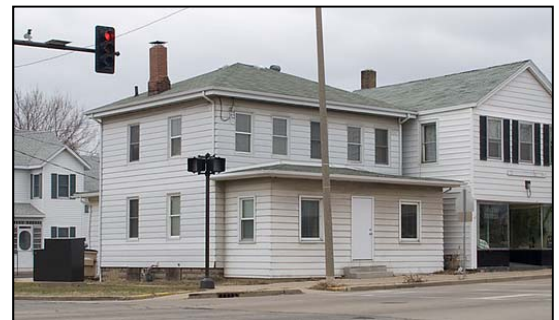
Photo ID: 103

Late 19th-century Italianate domestic structure retains its original massing, window penetrations and roofline. An enclosed porch stretches across the five-bay main façade; the secondary façade presents two window bays.

Porch enlarged after 1913 and enclosed after 1949.

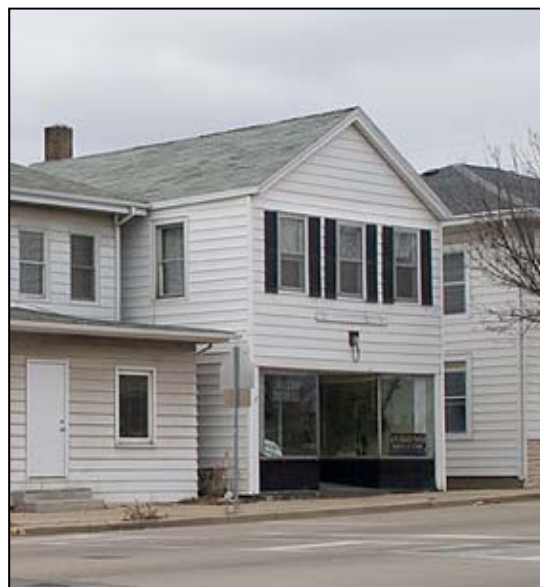
Photo ID: 103

Commercial structure with living space above retains its original function. First floor plate glass storefront with central entrance stretches across the entire façade. The second floor, sheathed in aluminum siding, presents three closely-spaced window penetrations. The front-gabled roof may have been a later addition.

Application of aluminum siding and shutters is reversible.

The building was being used as a grocery in 1888. Although the gable roof may not be original, the building's massing, window penetrations, and storefront help maintain sufficient integrity for a contributing structure.

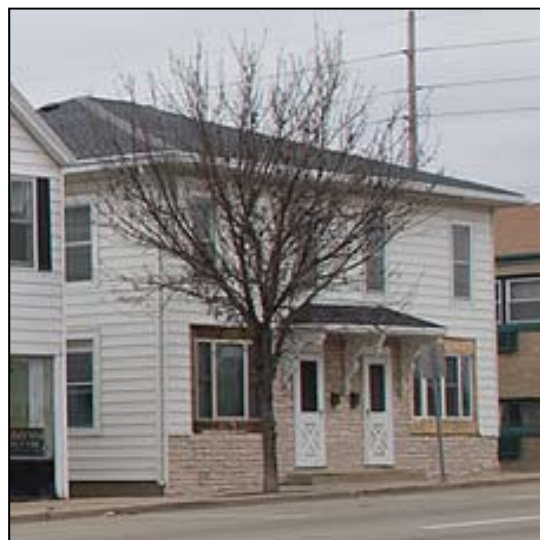
Photo ID: 103

Late-Victorian duplex residential building with central entries and shared porch roof. The main façade presents six bays. Walls have been sheathed with aluminum and faux stone. Windows have been replaced, using original penetrations, but entry doors appear to be original. The porch hood appears to be original, including the decorative scrollwork above the double entryway. The building's original massing, window penetrations, and roofline all appear to be in place.

Behind the primary building is a non-contributing outbuilding.

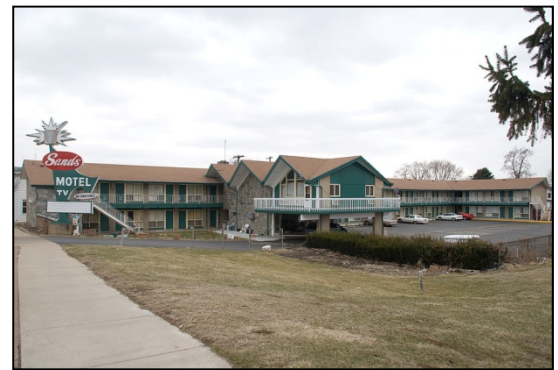
Photo ID: 105-1

Mid-century modern two-story motel. Main entrance includes a porte-cochère at the main entrance. Walls are clad with wooden vertical siding, brick and stone. Each room presents a set of four windows next to the door. Second floor walkway presents a simple black metal railing. Gabled roof with angled soffits produces a dynamic visual effect. A very good example of the style. Some wooden siding and the railings have been replaced, but other materials are original. Lower windows were originally awning-style; some windows have been replaced with contemporary double-hung vinyl windows.

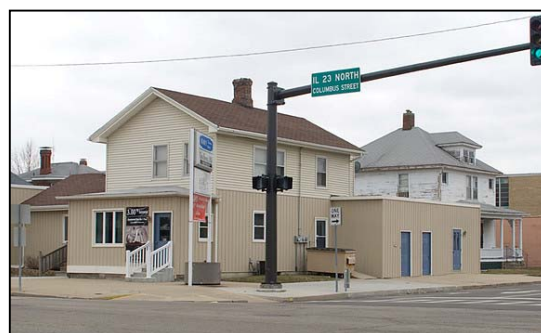
Photo ID: 042

Use of modern materials, replacement windows, etc. leave insufficient character-defining features for this structure to be individually listed. However, the building's massing, including the storefront to the south, has been unchanged since the 1920s.

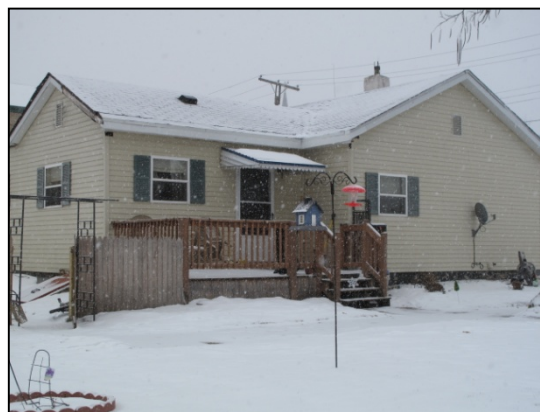
Photo ID: 011

Plan: Rectangular      Stories: 2  
 Roof Type: Front Gable  
 Foundation: CONCRETE, CMUs  
 Walls: WOOD  
 Sheathing: SYNTHETICS  
 Windows: Double-Hung  
 Doors:  
 Trim: SYNTHETICS  
 Roofing: ASPHALT  
 Flashing:  
 Chimney: BRICK

Class:	Building	Condition:	Good	Integrity:	Low
Yes	1. Heritage value	<b>Individual Eligibility</b>			
No	2. Events (A)	Scope:			
No	3. Persons (B)	NHL:	No	Individual	No
		NR:			
No	4. Architect (C)	<b>District Eligibility</b>			
No	5. Design Elements (C)	District Name:			
No	6. Architectural Style (C)				
No	7. Archaeology (D)	Contributing: No			
No	8. Utilitarian Structure	NR Criteria Considerations:			
Yes	9. Sense of Place	N/A

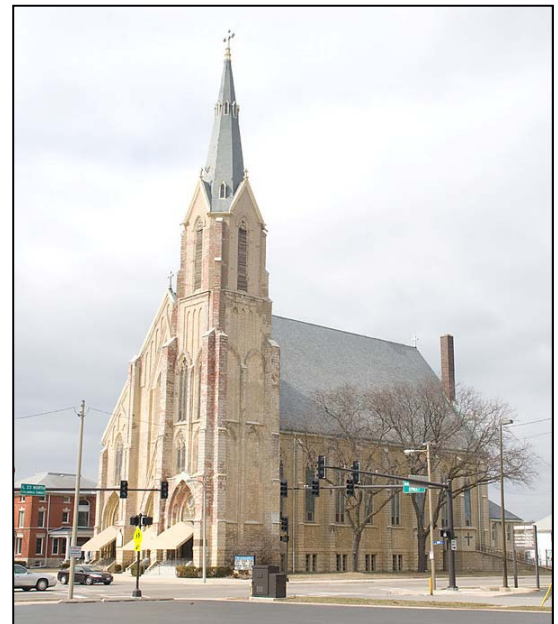
Photo ID: 213-1

Late 19th-century Gothic Revival church of brick with stone foundation. Windows and entries marked by Gothic arches typical of the style. Bell tower rises with corner buttresses at the right of the main entry to a cross-shaped gable roof surmounted by a tall steeple. The building was sheathed in stone veneer during the early 20th century, and the bond between the brick and veneer has failed in many places.

Application of stone veneer prior to the 1972 Survey. Veneer matched the foundation stone, and is now in disrepair, revealing original brick in places. This deterioration is evident in the 1972 survey photo.

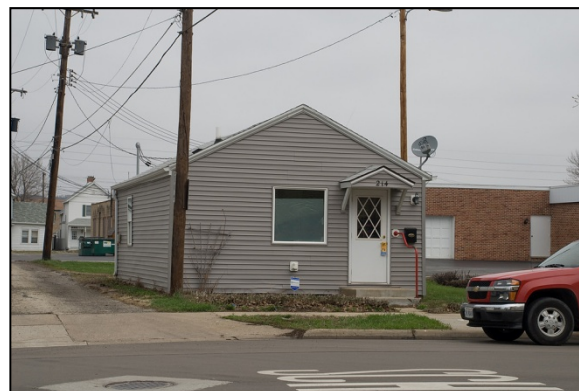
Photo ID: 205

Address: 214 West Washington Street	PIN: 21-11-217-011	Plan: Rectangular	Stories: 1
Original Owner:		Roof Type: Gable end	
Building Names:		Foundation: CONCRETE	
Important Dates: ca 1880		Walls: WOOD	
Architect / Builder:		Sheathing: SYNTHETICS	
Architectural Style: Other		Windows: Double-Hung	
		Doors: WOOD, GLASS	
Historic Function: DOMESTIC: single dwelling		Trim:	
Current Function: DOMESTIC: single dwelling		Roofing: ASPHALT	
References: Sanborn first maps this area in 1883.		Flashing:	
		Chimney: BRICK

Class: Building	Condition: Good	Integrity: Low
No 1. Heritage value	<b>Individual Eligibility</b>	
No 2. Events (A)	Scope:	
No 3. Persons (B)	NHL: No	Individual No
	NR:	
No 4. Architect (C)	<b>District Eligibility</b>	
No 5. Design Elements (C)	District Name:	
No 6. Architectural Style (C)	Ottawa Commercial Historic District	
No 7. Archaeology (D)	Contributing: No	
No 8. Utilitarian Structure	NR Criteria Considerations:	
Yes 9. Sense of Place	N/A

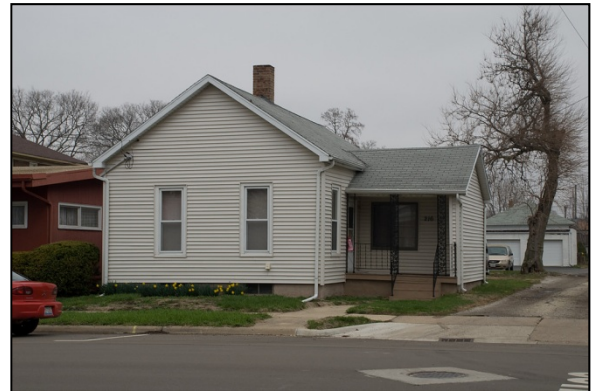
Photo ID: 207

Address: 216 West Washington Street	PIN: 21-11-217-009	Plan: T	Stories: 2
Original Owner:		Roof Type: Front Gable	
Building Names:		Foundation: CONCRETE	
Important Dates: ca 1885		Walls: WOOD	
Architect / Builder:		Sheathing: SYNTHETICS	
Architectural Style: Other		Windows: Double-Hung	
		Doors: WOOD, GLASS	
Historic Function: DOMESTIC: single dwelling		Trim:	
Current Function: DOMESTIC: single dwelling		Roofing: ASPHALT	
References: Estimated date based on 1883 and 1888 Sanborn Maps.		Flashing:	
		Chimney: BRICK

Class: Building	Condition: Good	Integrity: Medium
Yes 1. Heritage value	<b>Individual Eligibility</b>	
No 2. Events (A)	Scope: Local	
No 3. Persons (B)	NHL: No Individual	No
	NR:	
No 4. Architect (C)	<b>District Eligibility</b>	
No 5. Design Elements (C)	District Name:	
No 6. Architectural Style (C)		
No 7. Archaeology (D)	Contributing: No	
No 8. Utilitarian Structure	NR Criteria Considerations:	
Yes 9. Sense of Place	N/A

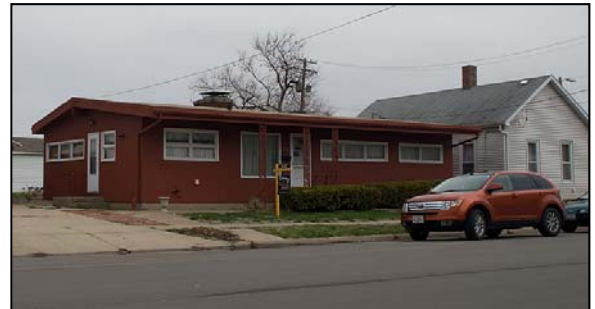
Photo ID: 209

Address: 218 West Washington Street	PIN: 21-11-217-019	Plan: Rectangular	Stories: 1
Original Owner:		Roof Type: gable	
Building Names:		Foundation: CONCRETE	
Important Dates: ca 1955		Walls: WOOD	
Architect / Builder:		Sheathing: WOOD	
Architectural Style: Modern Movement: Modern, General		Windows: Plate Glass, Hopper Style	
		Doors: WOOD	
Historic Function: DOMESTIC: single dwelling		Trim: WOOD	
Current Function: DOMESTIC: single dwelling		Roofing: ASPHALT	
References:		Flashing: SYNTHETICS	
		Chimney: BRICK

Class: Building	Condition: Excellent	Integrity: High
Yes 1. Heritage value	<b>Individual Eligibility</b>	
No 2. Events (A)	Scope: Local	
No 3. Persons (B)	NHL: No	Individual No
		NR:
No 4. Architect (C)	<b>District Eligibility</b>	
No 5. Design Elements (C)	District Name:	
Yes 6. Architectural Style (C)	Ottawa Commercial Historic District	
No 7. Archaeology (D)	Contributing: No	
No 8. Utilitarian Structure	NR Criteria Considerations:	
Yes 9. Sense of Place	N/A

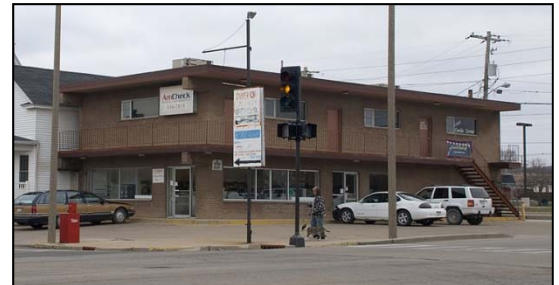
Photo ID: 202

Address: 100-106 West Superior Street	PIN: 21-11-210-016	Plan: Rectangular	Stories: 2
Original Owner:		Roof Type: Flat	
Building Names:		Foundation:	
Important Dates: ca 1950		Walls: BRICK	
Architect / Builder:		Sheathing:	
Architectural Style: Modern Movement: International Style		Windows: Plate Glass, Double-Hung	
		Doors: METAL, GLASS	
Historic Function: COMMERCE: specialty store		Trim: METAL	
Current Function: COMMERCE: specialty store		Roofing:	
References:		Flashing:	
		Chimney:

Class: Building	Condition: Excellent	Integrity: High
Yes 1. Heritage value	<b>Individual Eligibility</b>	
No 2. Events (A)	Scope: Local	
No 3. Persons (B)	NHL: No	Individual No
	NR:	
No 4. Architect (C)	<b>District Eligibility</b>	
Yes 5. Design Elements (C)	District Name:	
Yes 6. Architectural Style (C)	Ottawa Commercial Historic District	
No 7. Archaeology (D)	Contributing: Yes	
No 8. Utilitarian Structure	NR Criteria Considerations:	
Yes 9. Sense of Place	N/A

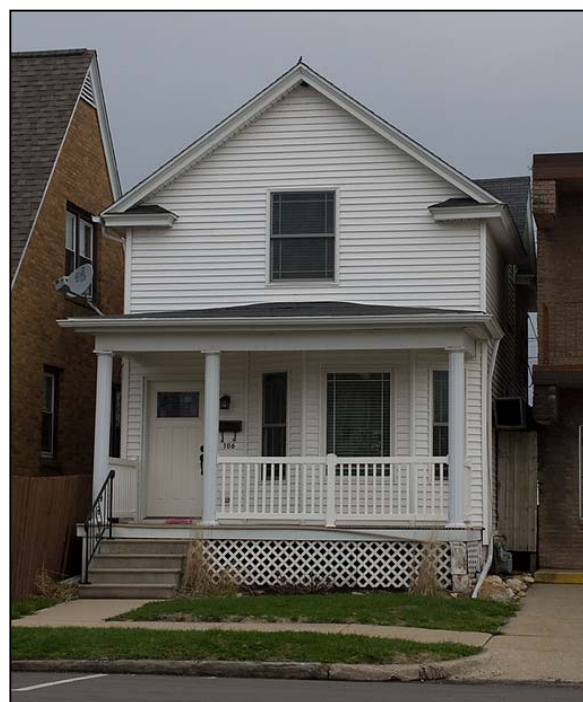
Photo ID: 222

Plan: Rectangular Stories: 1.5  
Roof Type: Front Gable  
Foundation:  
Walls: WOOD  
Sheathing: WOOD  
Windows: Double-Hung, Plate Glass  
Doors: WOOD  
Trim:  
Roofing: ASPHALT  
Flashing:  
Chimney:

Class: Building Condition: Good Integrity: Medium

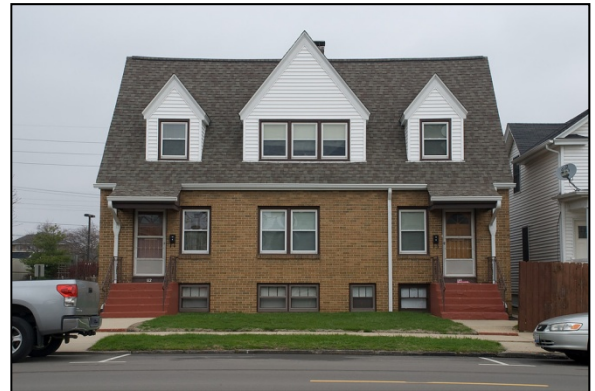
Photo ID: 203

Address: 110-112 West Superior Street	PIN: 21-11-210-018	Plan: Rectangular	Stories: 1.5
Original Owner:		Roof Type: Side Gable	
Building Names:		Foundation:	
Important Dates: ca 1920		Walls: BRICK	
Architect / Builder:		Sheathing: SYNTHETICS	
Architectural Style: Revivals, Late 19th / Early 20th C: Tudor Revival		Windows: Double-Hung	
		Doors: WOOD	
Historic Function: DOMESTIC: multiple dwelling		Trim:	
Current Function: DOMESTIC: multiple dwelling		Roofing: ASPHALT	
References: Estimated date based on 1913 and 1925 Sanborn Maps.		Flashing:	
		Chimney: BRICK

Class: Building	Condition: Good	Integrity: High
Yes 1. Heritage value	<b>Individual Eligibility</b>	
No 2. Events (A)	Scope: Local	
No 3. Persons (B)	NHL: No Individual NR:	No
No 4. Architect (C)	<b>District Eligibility</b>	
Yes 5. Design Elements (C)	District Name:	
Yes 6. Architectural Style (C)	Ottawa Commercial Historic District	
No 7. Archaeology (D)	Contributing: Yes	
No 8. Utilitarian Structure	NR Criteria Considerations:	
Yes 9. Sense of Place	N/A

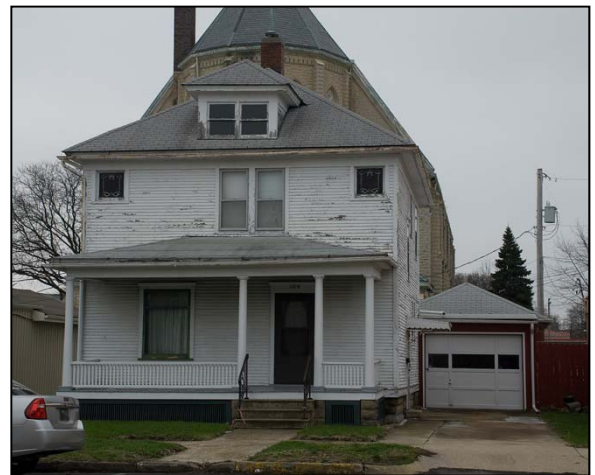
Photo ID: 192

Fine example of a wooden American Foursquare in very good condition. Simple Doric columns and characteristically low railing on front porch suggest that these materials are original. Possible replacement windows on second floor.

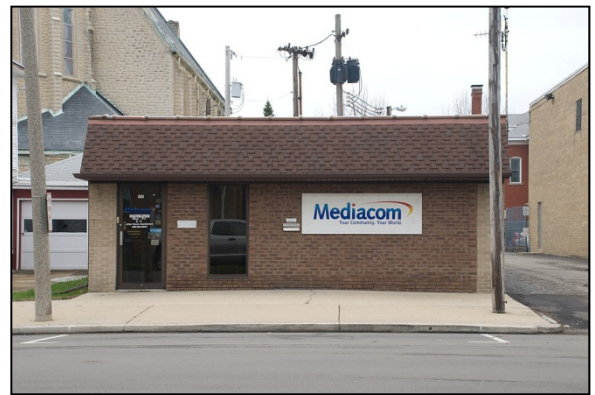
Photo ID: 193

Simple rectangular one-story masonry commercial structure has a mansard-type hood of asphalt shingles stretching across the entire building. Storefront has been replaced with red brick fill, a single metal and glass doorway and narrow window.

Storefront replaced and hood added after original construction.

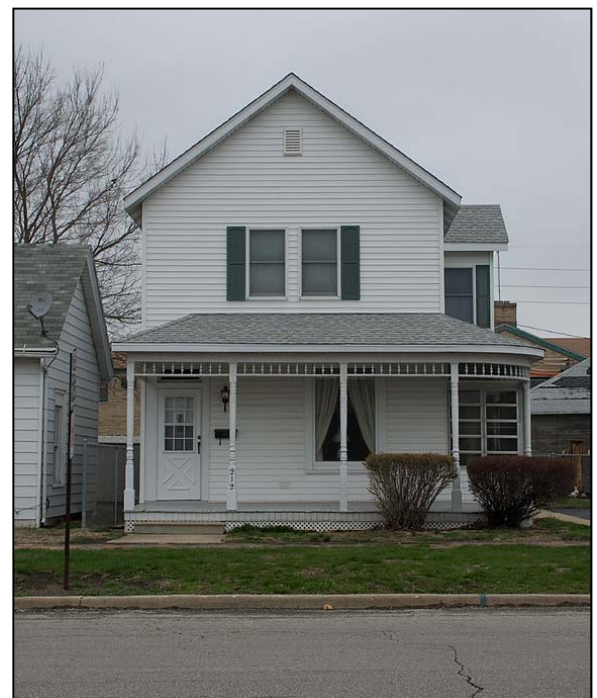
Photo ID: 194

It is likely some windows openings have been covered on the west façade. Replacement windows appear to have been added at the southeast corner of the building.

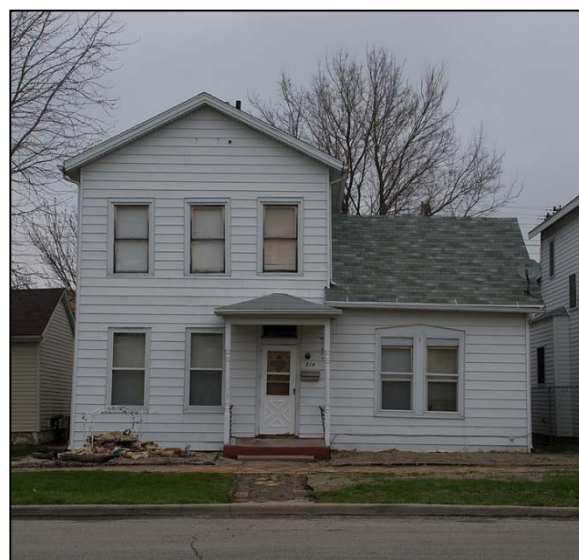
Photo ID:

Plan: L Stories: 2  
 Roof Type: Front Gable  
 Foundation:  
 Walls: WOOD  
 Sheathing: METAL  
 Windows: Double-Hung  
 Doors: WOOD  
 Trim:  
 Roofing: ASPHALT  
 Flashing:  
 Chimney: BRICK

Class: Building Condition: Good Integrity: Medium

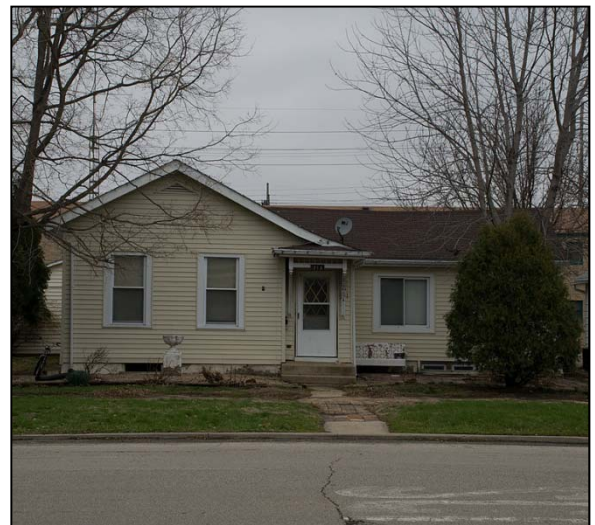
Photo ID: 197

Plan: Irregular Stories: 1  
 Roof Type: Front Gable  
 Foundation: CONCRETE  
 Walls: WOOD  
 Sheathing: SYNTHETICS  
 Windows: Double-Hung, Plate Glass  
 Doors: WOOD, GLASS  
 Trim:  
 Roofing:  
 Flashing:  
 Chimney: BRICK

Class: Building Condition: Good Integrity: Medium

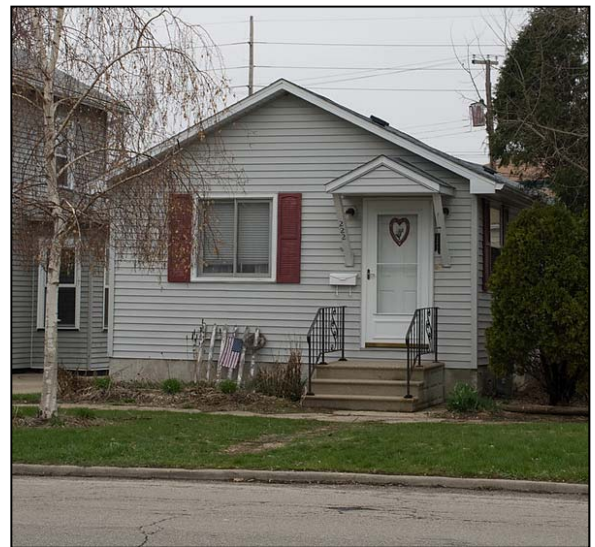
Photo ID: 198

Single-story frame front-gable residence typical of the period. Shape of windows on east facade suggests 1950's vintage, probably replacement windows. Building also has vinyl shutters.

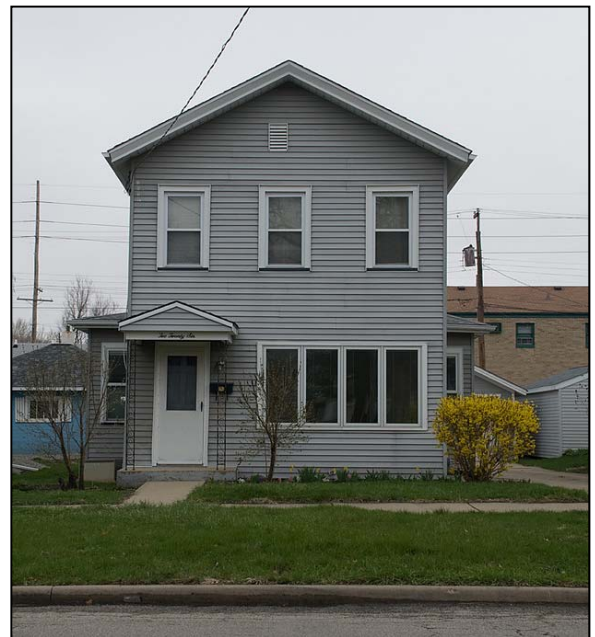
Photo ID: 199

Replacement windows on first floor detract from integrity. Building's massing would allow classification as contributing structure.

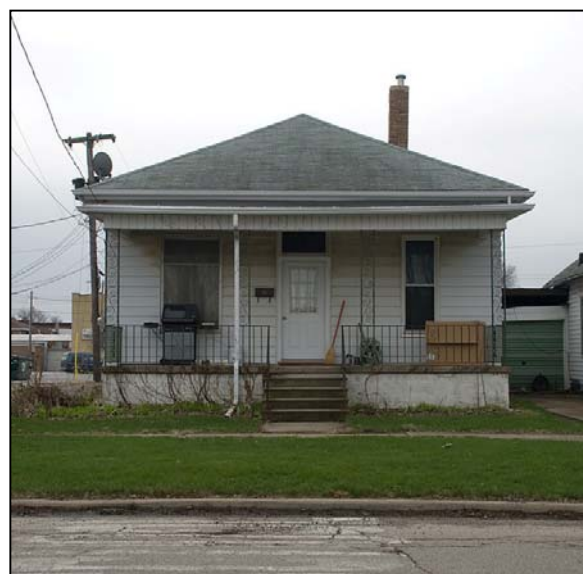
Photo ID: 196

One-story frame home with asymmetrical three-bay façade, with windows and entryway on main façade possibly replaced in the 1920s. Porch of CMUs and concrete stretches the full length of the main façade, and has a canopy of wood and asphalt shingles supported by mid-20th-century metal supports. The building's original massing and roofline appear to be in place. Window penetrations on the east façade retain their original proportions.

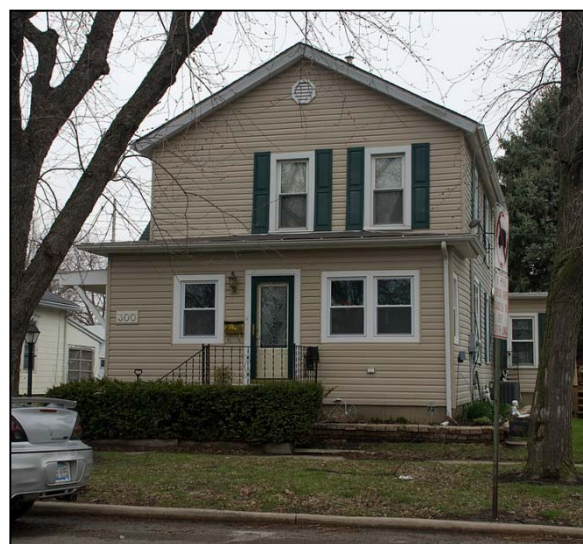
Photo ID: 201

Class:	Building	Condition:	Good	Integrity:	Medium
Yes	1. Heritage value	<b>Individual Eligibility</b>			
No	2. Events (A)	Scope:	Local		
No	3. Persons (B)	NHL:	No	Individual	No
		NR:			
No	4. Architect (C)	<b>District Eligibility</b>			
No	5. Design Elements (C)	District Name:			
No	6. Architectural Style (C)				
No	7. Archaeology (D)	Contributing:	No		
No	8. Utilitarian Structure	NR Criteria Considerations:	N/A		
Yes	9. Sense of Place
